TCP/IND/6712
Field Document No. 4

TRAINING IN SEA SAFETY DEVELOPMENT

Based on the Work of
Oyvind Gulbrandsen
FAO Consultant Naval Architect
(2 June – 2 July 1998)

FOOD AND AGRICULTURE ORGANIZATION OF THE UNITED NATIONS
Bangkok, August 1998

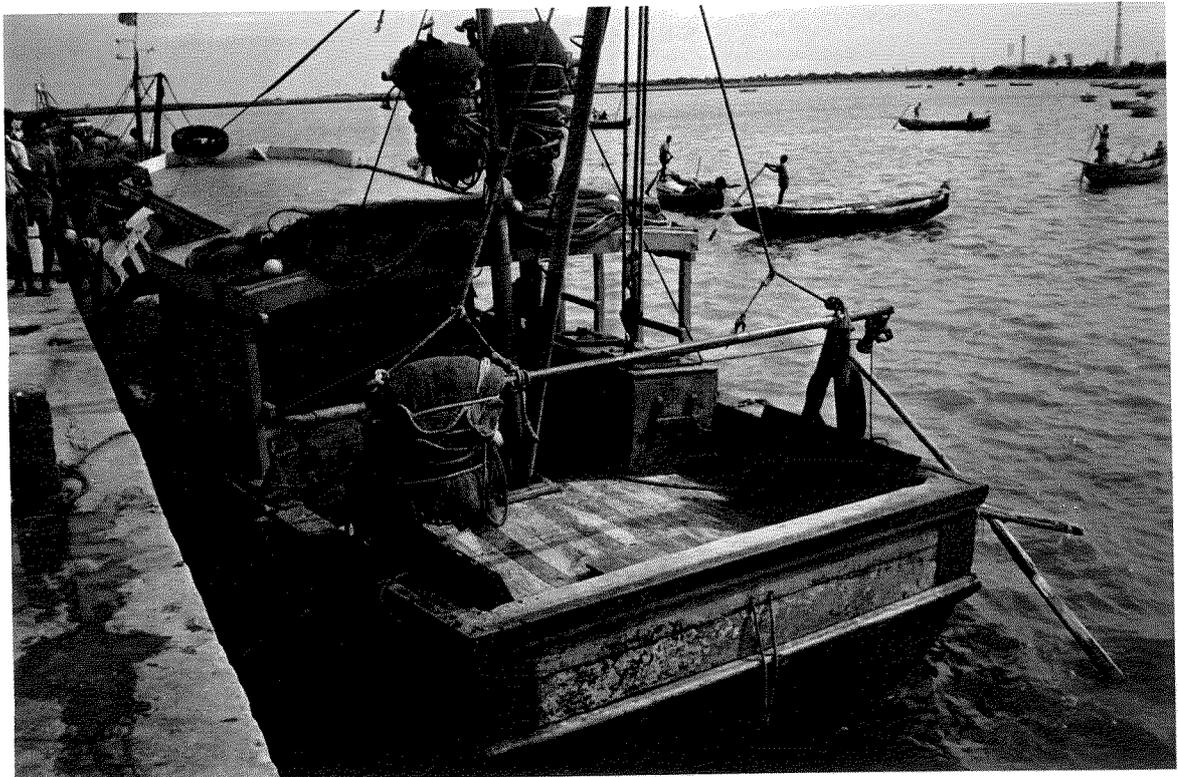
Fig. 6. Trawler with iceboxes on deck

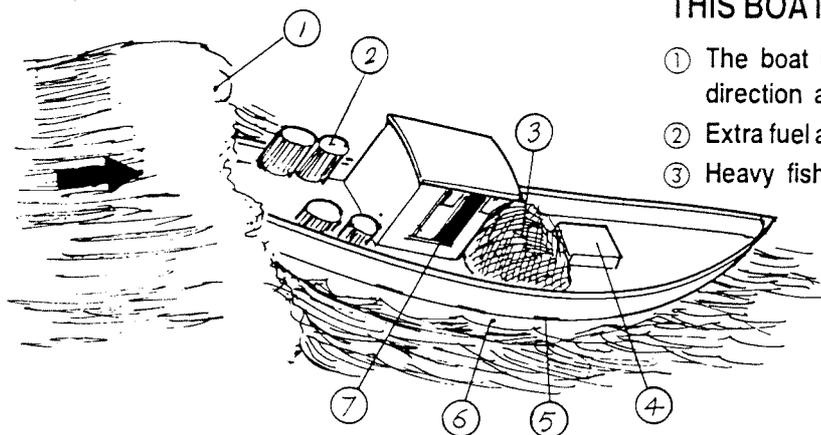
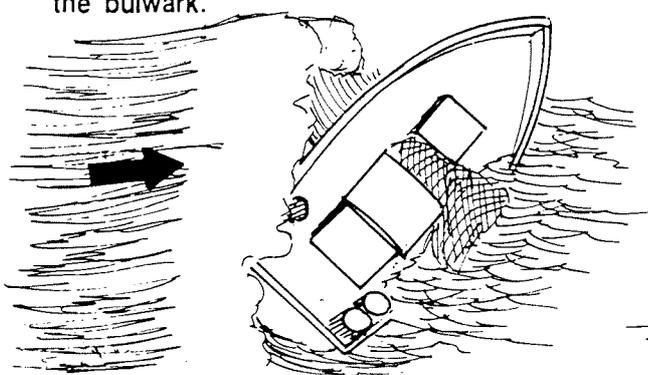
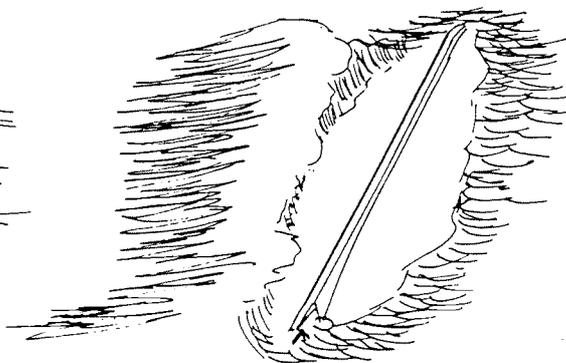
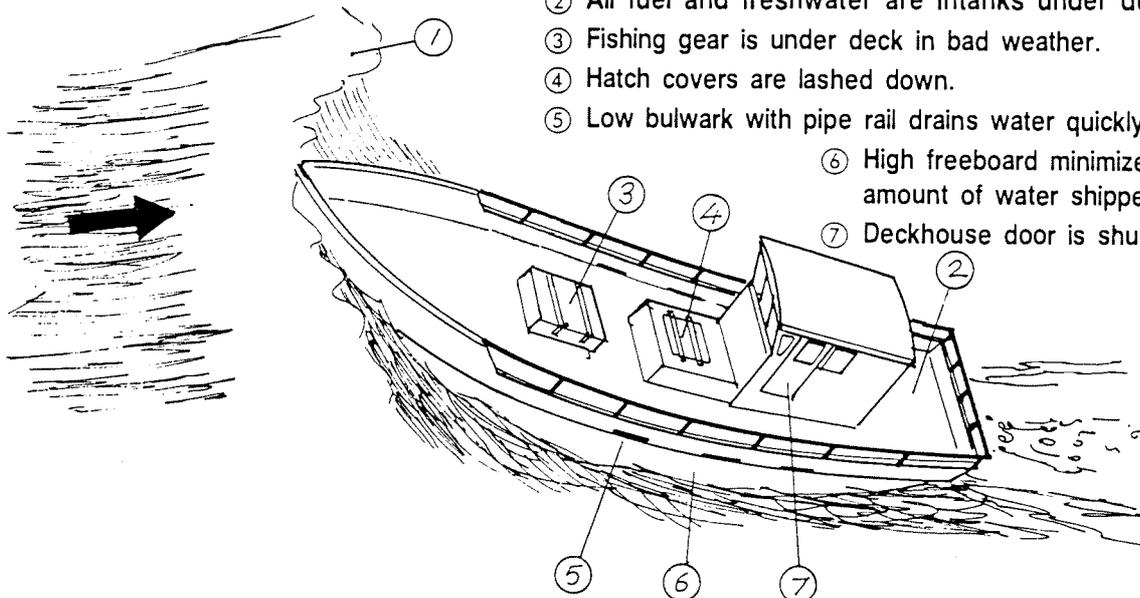
Fig 7. Causes for capsize

- When the trawlers were hit by the cyclone late at night on 6 November 1996, the first thought of the skipper was usually to head back to Kakinada. When the wind and wave direction made progress very slow, they decided to turn around and go with the wind and the waves in order to seek the nearest port in that direction. A breaking wave from astern or the side filled the deck, washed away unsecured hatch covers, filled up the engine room and stopped the engine. The boat could not be manoeuvred and capsized from a side wave (Fig. 7).

- ① The boat is going full speed in the same direction as the waves
- ② Extra fuel and fresh water are in drums on deck.
- ③ Heavy fishing gear is on deck.
- ④ Hatch covers are not lashed.
- ⑤ Freeing ports are small.
- ⑥ Freeboard is low.
- ⑦ Deckhouse door is open.

The boat is likely to be thrown broadside to the waves and the fishing gear and drums are likely to slide over the bulwark.

The boat is then likely to capsize with the next large wave.

- ① The boat is going slowly against the waves.
- ② All fuel and freshwater are in tanks under deck.
- ③ Fishing gear is under deck in bad weather.
- ④ Hatch covers are lashed down.
- ⑤ Low bulwark with pipe rail drains water quickly.
- ⑥ High freeboard minimizes the amount of water shipped in.
- ⑦ Deckhouse door is shut.

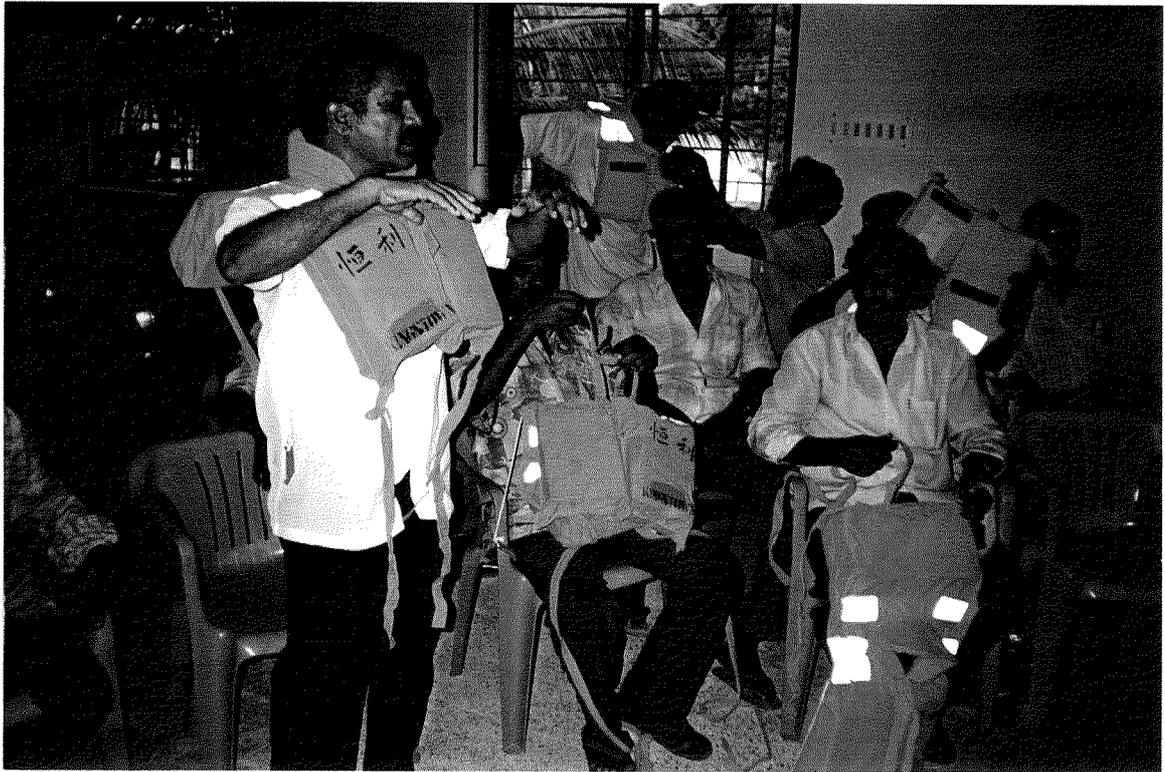
Fig.8. Training course for staff from Fisheries Training Institute and Fisheries Department. Participants were asked to tie on a lifejacket. None were able to do it without further training.

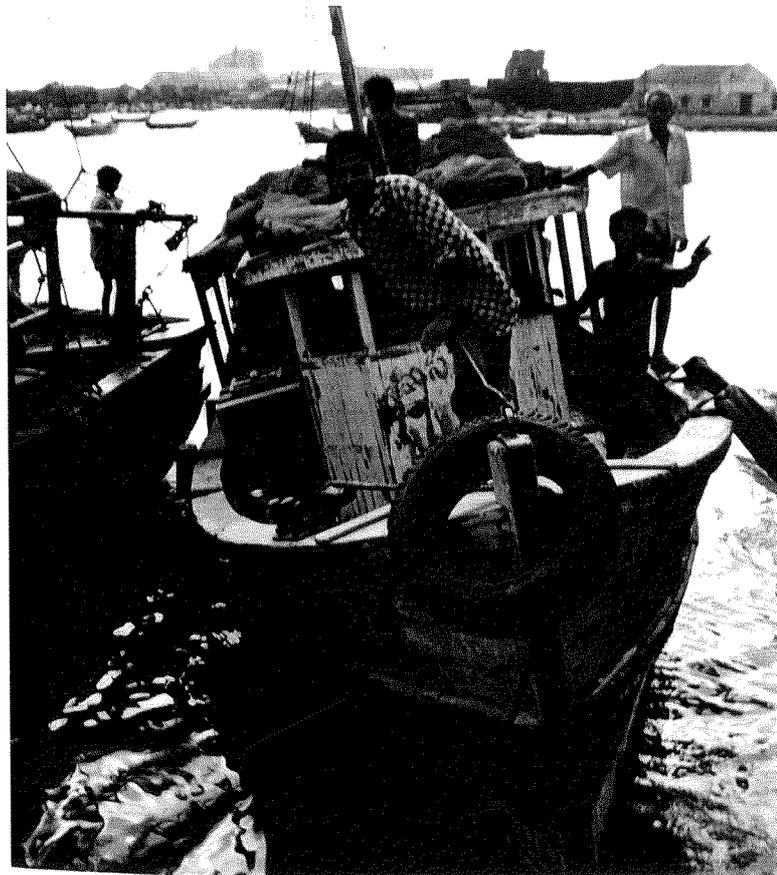
Fig.9. 10 m "Royya" type of trawler with icebox on deck. Angle of heel when arriving in port indicates low stability.

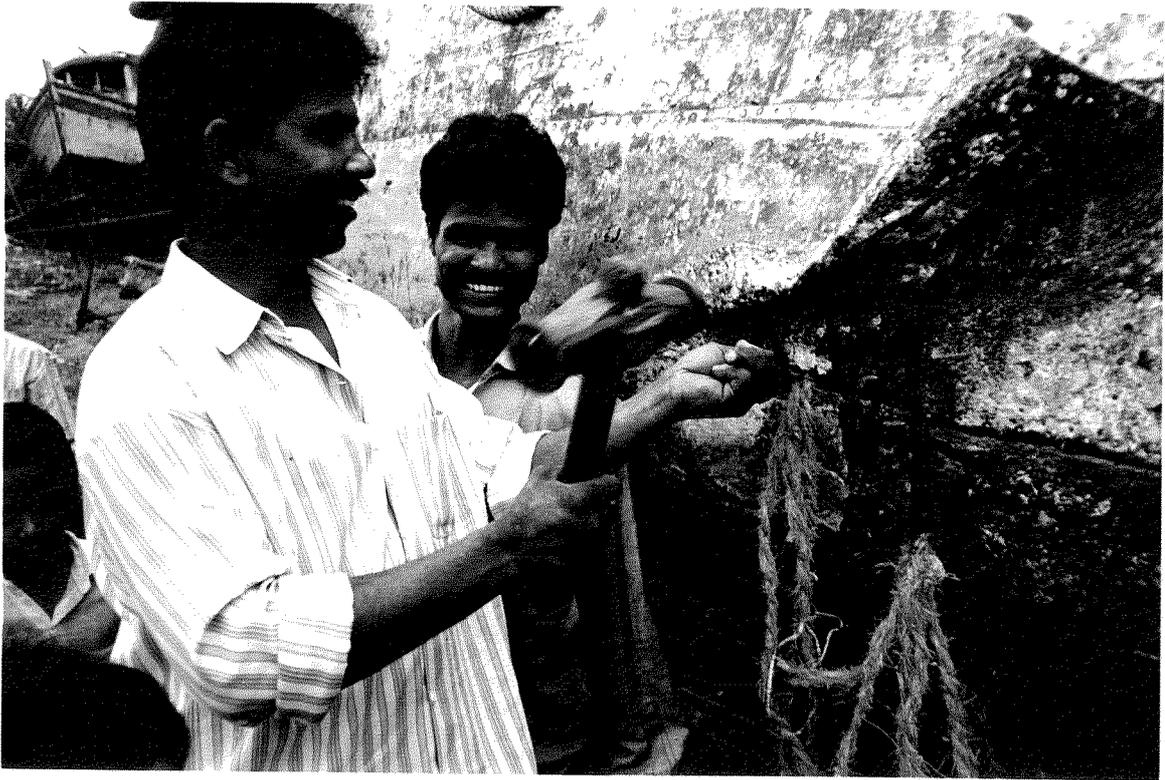
- Big gaps between the planks occur after a few years service and this requires massive caulking to stop the leak (Fig. 10). Although it is not possible to directly link the weak construction of the trawlers to the sinkings during the cyclone, it is clear that the present scantlings present a safety hazard.

Fig. 10. A leak in a five year old trawler is stopped by massive caulking. The large gaps between the planks are caused by weak construction

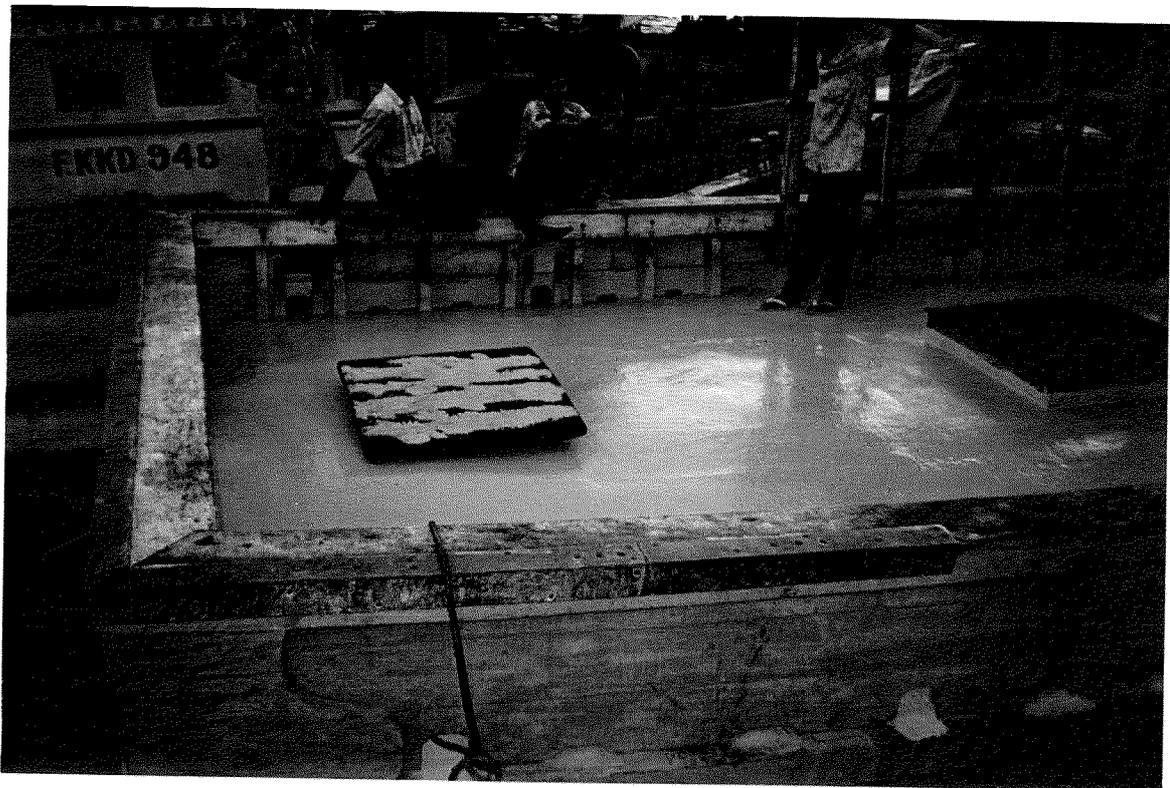
- In many cases the hatch covers to the fish hold and to the rudder compartment cannot be fastened down in such a way that they will not be washed away by a wave breaking on the deck (Fig. 11). The height of the hatch coaming, which is recommended (Ref. 5) to be minimum 300 mm, is in most cases half this height or less. This also applies to the coaming height for doors into the wheelhouse where water will enter easily into the engine room.

- The scuppers in the bulwark (Fig 11) should be sufficiently large to prevent large quantities of water being trapped on deck. They have a combined area of about one third of what is recommended (Ref. 5).

Fig. 11. This is a typical trawler with no means to clamp down the hatchcovers. Drainage openings (scuppers) in the bulwark are about one third the size recommended by international guidelines

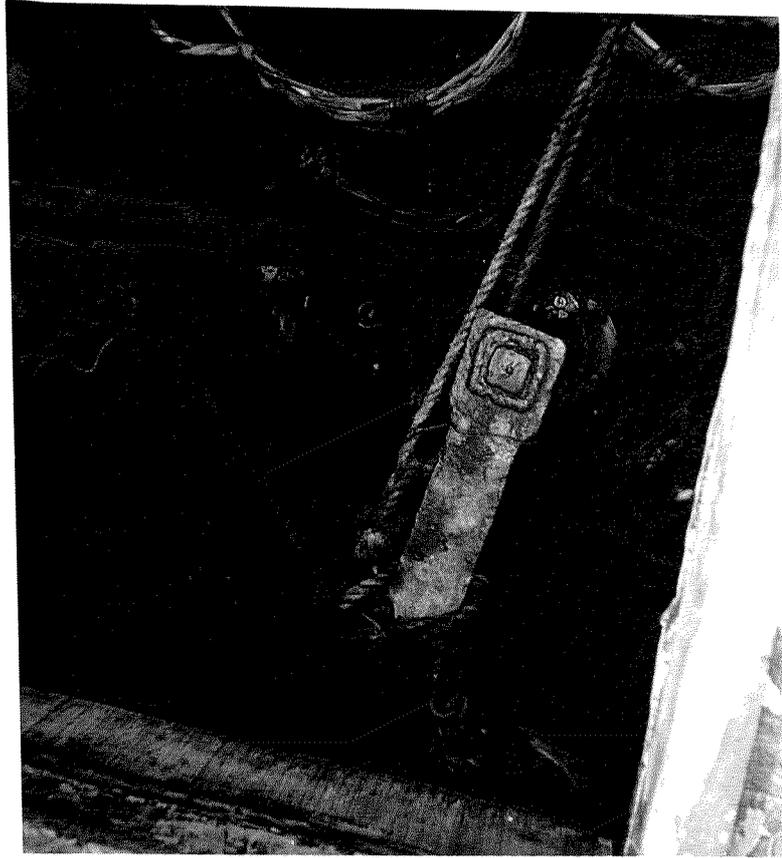
Fig.12. The rudder tiller is connected to the steering wheel by rope. No proper rudder stops. This is not acceptable on a 12 m trawler. Breaking of this rope was the cause for the loss of at least one trawler during the cyclone.

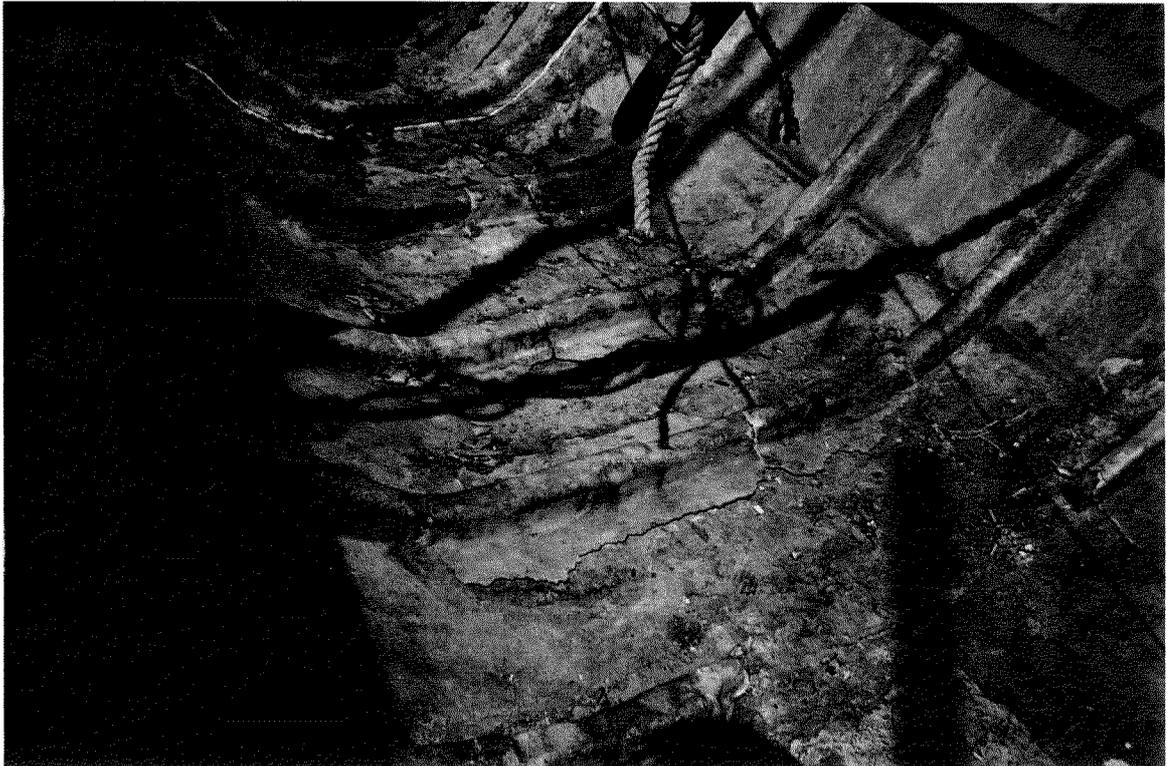
Fig.13. Poor workmanship and frames of insufficient strength have caused considerable damage in this FRP boat, only two years old
