## APPENDIX 4

### *Investment Plan for the Development of Climate Resilient Fisheries Infrastructure in Grand Bahama and Abaco Islands (draft version)*

## Fishery Infrastructure Inventory of Grand Bahama and Abaco Islands

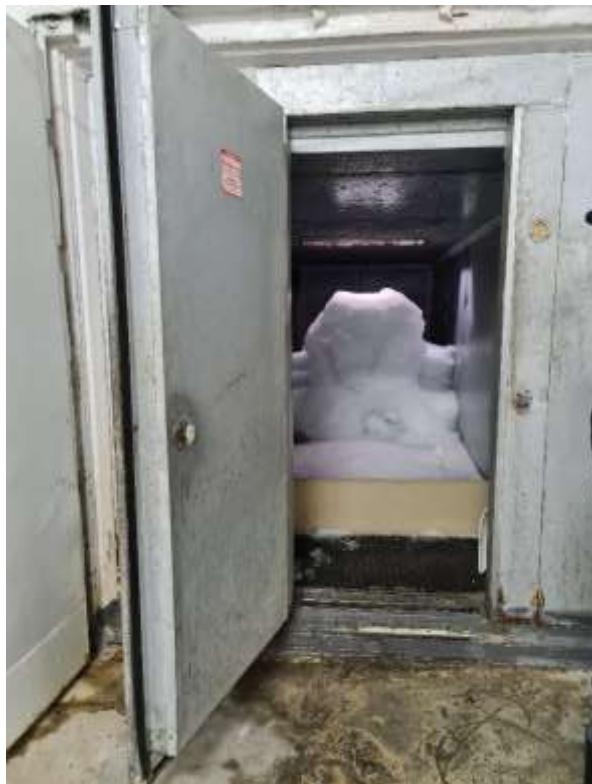
**Figure 1-** Icemaker that was restored after Hurricane Dorian.

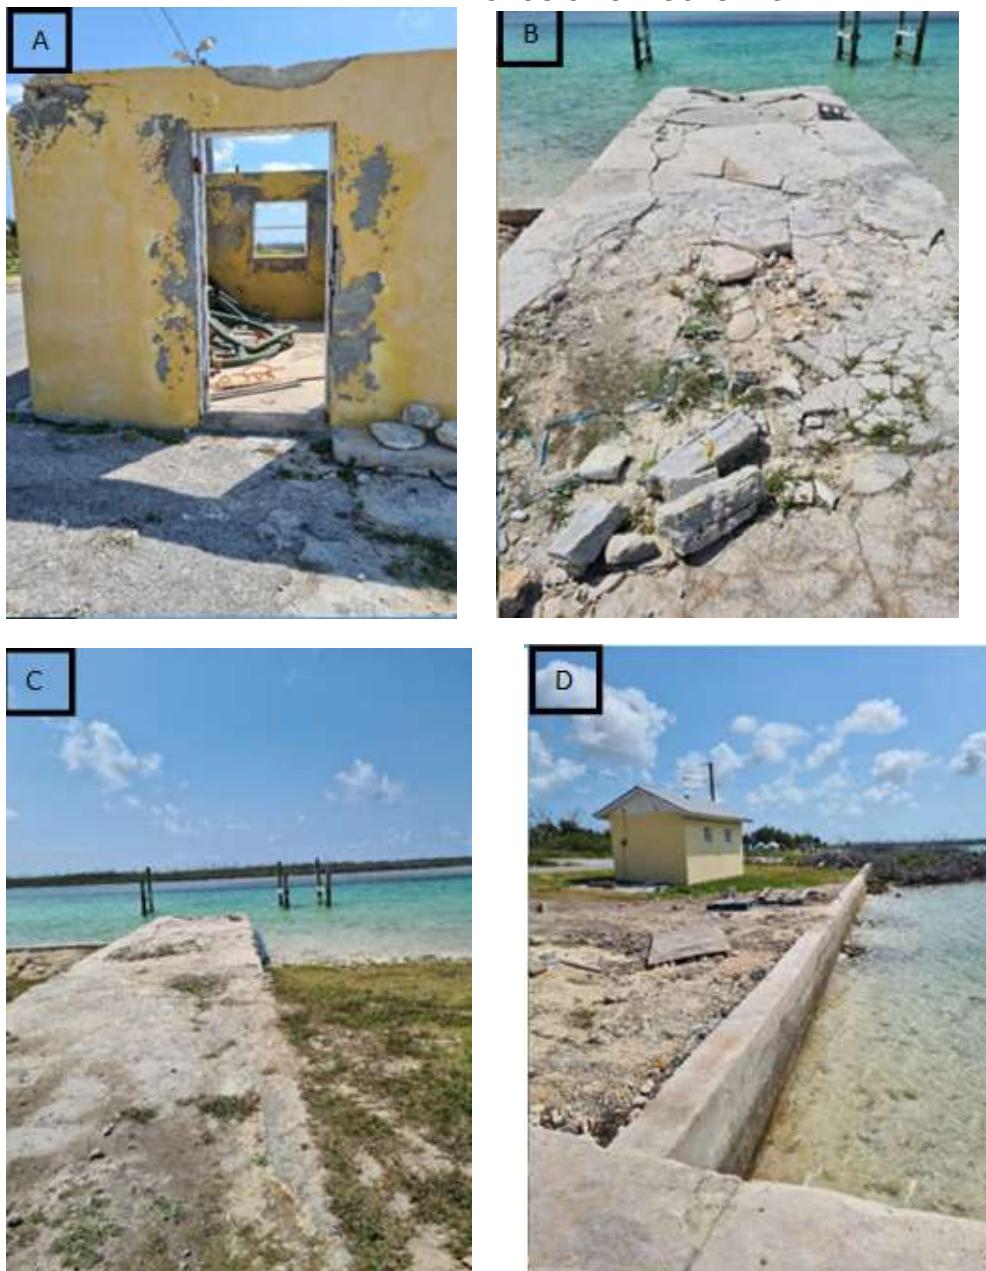
**Figure 1** – Sweeting's Cay administration building (A), public dock (B & C), and restroom facilities (D).

TYPE	EXISTING	DAMAGED	PROPOSED	OUTLINE COST U\$
Breakwater	-			0.00
Quay wall	-			0.00
Jetty on piles	Yes	Yes	Repair	0.00
Slipway	Yes	Yes	Repair	0.00
Gear Stores	-			0.00
Net repair shed	-			0.00
Engine repair	-			0.00
Fish sales Hall	-			0.00
Admin building	-Yes	Yes	Repair	0.00
Cool Store	-			0.00
Ice maker	-			0.00
Water Tanks	-			0.00
Fuel Tanks	-			0.00
Septic Tanks	Yes	Yes	Repair	0.00
Equipment	-			0.00
