Rubagano rooftop rainwater harvesting system (with concrete/brick tank) Uganda - Okwombeka tanka z'amaizi ahamaju (Runyankore)

Rain-water from all corrugated iron roof structures in one compound is harvested and stored in underground tanks.

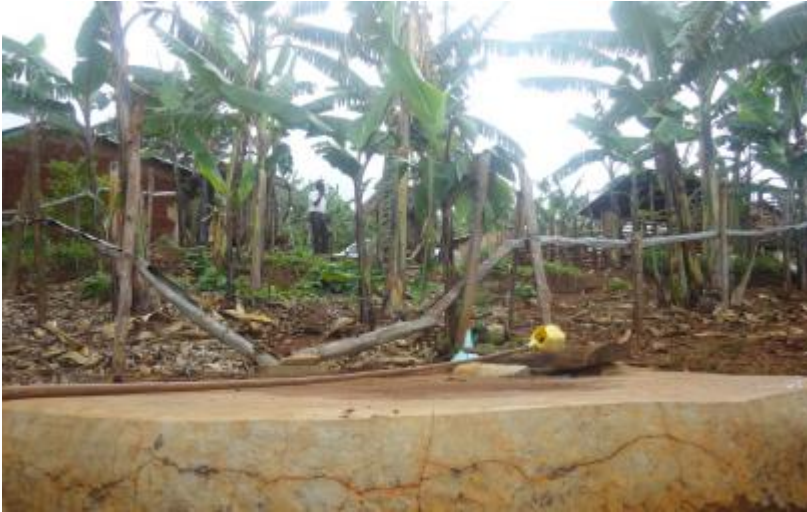
left: The water harvesting system with 3 components: the corrugated iron roof, the gutters and the storage tank (Photo: Charles L Malingu)

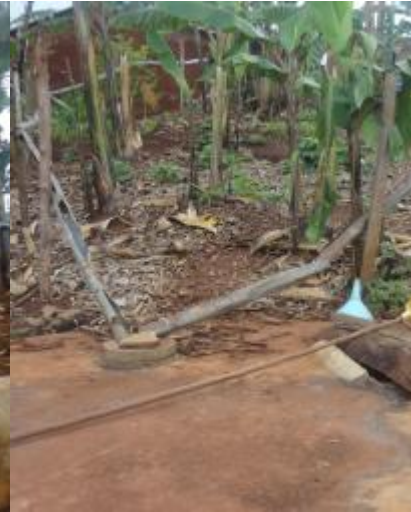
right: The storage tank capacity determines how long, during a dry spell, the farm household will stay water secure. A typical tank is 3m to 4m deep and 2.5m to 3.0m in diameter (Photo: Charles L Mlingu)

The calculations were done for a 38.0 cubic meter tank constructed in September 2013
