A community-driven agroecological restoration of a dam through GIS and Remote Sensing integration

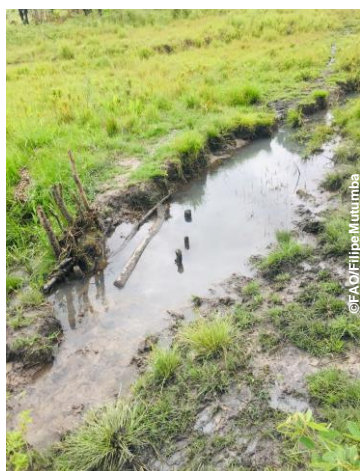
Water course before dam restoration

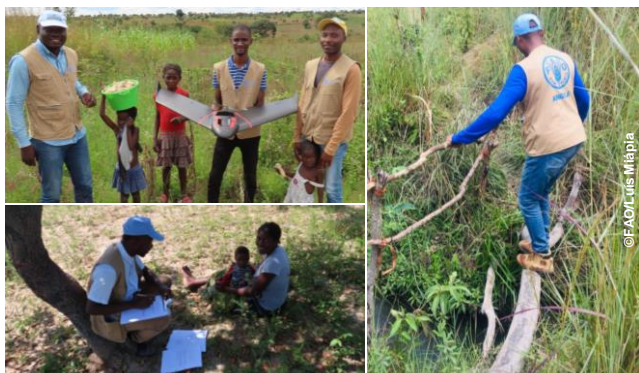
Application of LADA methodology

As an integral part of the methodology, the use of a drone was instrumental in meticulously mapping land cover and terrain, providing critical insights for the evaluation process by allowing flood simulations and accurate estimation of storage capacity, aiding in further decisions.

The determination to restore the dam stemmed directly from the comprehensive insights gained through the application of the LADA methodology (Land Degradation Assessment in Dryland Areas) applied in Ngunga sector. The LADA methodology involved an evaluation of current land degradation, its underlying causes, and impacts, while also identifying sustainable agricultural approaches and training needs in agroecological practices within areas of intervention.

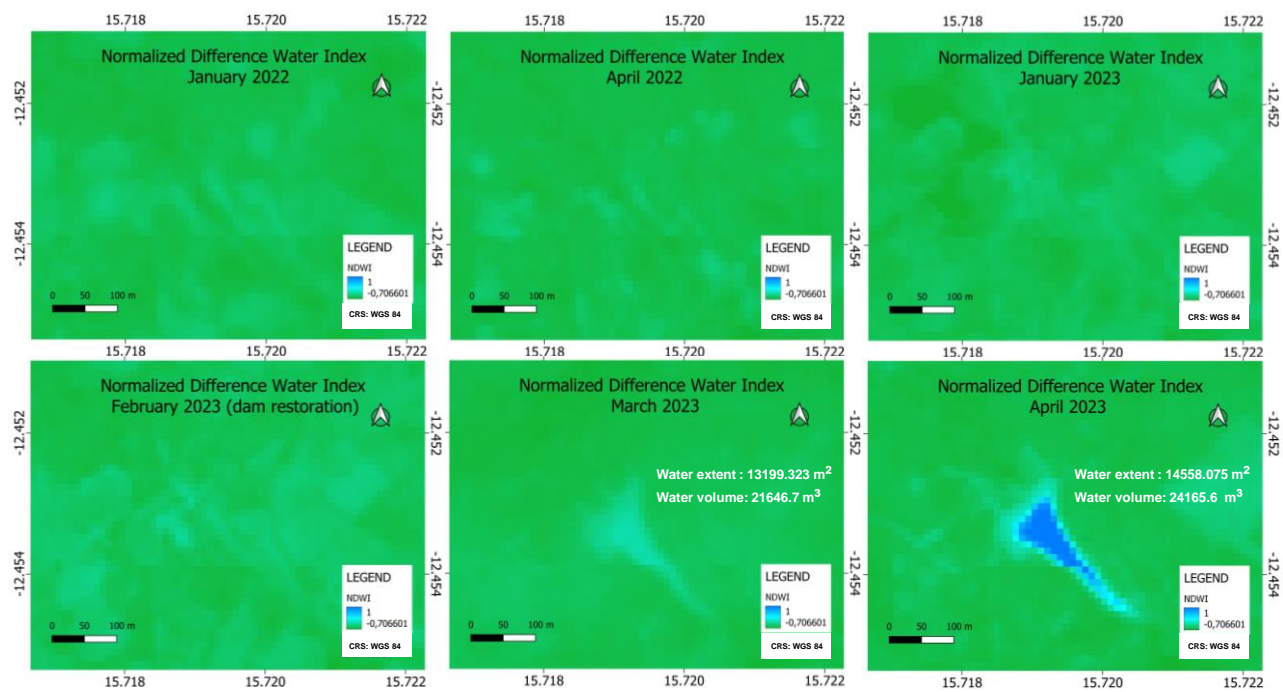
NDWI before and after dam restoration during the raining season

Employing Remote Sensing and Geographic Information Systems (GIS) facilitated the monitoring of water extent and volume, and irrigation channel lengths. The determination of water boundaries utilized the canny edge detection technique on Normalized Difference Water Index maps (NDWI, where values close to 1 indicate the presence of water) from NICFI PLANET images. Water volume estimation relied on specialized software, calculating the volume beneath the water boundaries outlined by the elevation model derived from drone data. Channel lengths were derived from GPS tracking.

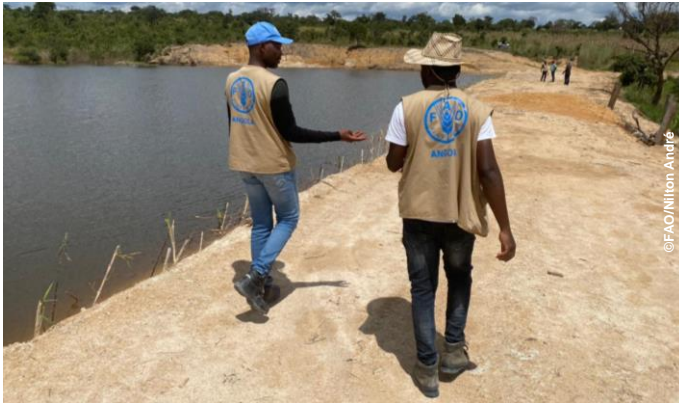
Dam and water retention area

With **24,000 m³ of water** available, the dam ensured reliable and consistent water supply for agricultural activities, livestock, and domestic use. Farmers can benefit from irrigation services, allowing a greater number of families rely on agricultural activity as a source of subsistence and income.

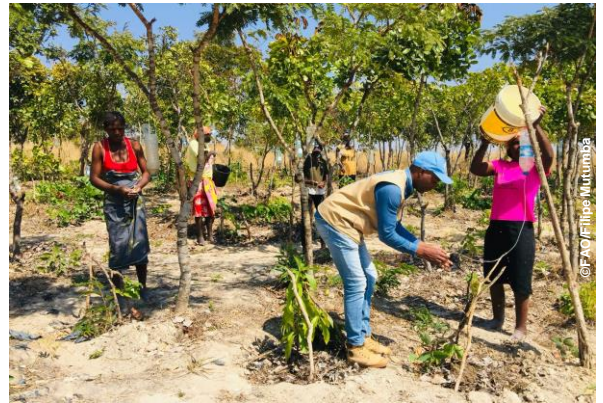
Water from the dam used for irrigation in agroforestry

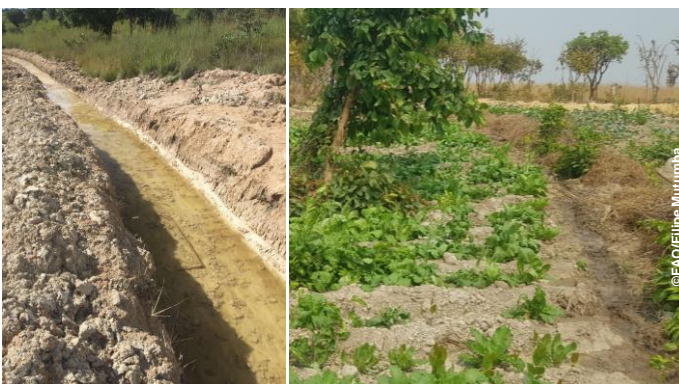
Irrigation channel, micro-channel and agriculture production

The two irrigation channels with **442** and **521 meters** of length respectively provided better irrigation systems, supporting increased crop yields and diversified agricultural production, thereby contributing to food security in the region, boosting incomes and livelihoods. Currently, **twenty-six hectares** of cultivated land enjoy year-round irrigation through micro-irrigation systems stemming from the two primary channels.
