The Coastal Vegetation Role in Protecting the Thailand Coast Against the 26th December 2004 Tsunami

Absornsuda Siripong

FAO Regional Technical Workshop "Coastal Protection in the Aftermath of the Indian Ocean Tsunami: What Role for Forests and Trees?"

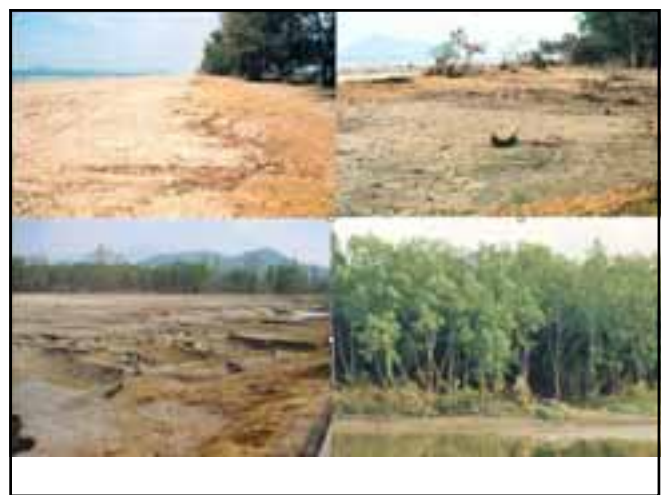
Run-up survey at Prapas Beach, Ranong province by Dr. Chugiat team.

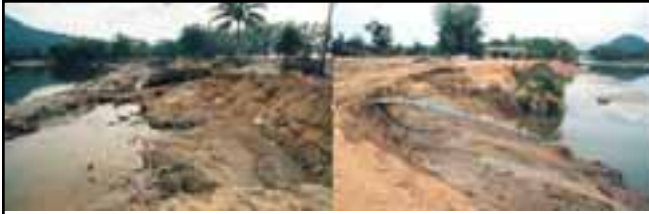
Erosion from tsunami run-up(left) and rundown (right) at Prapas Beach, Ranong Province on 30 December 2004.

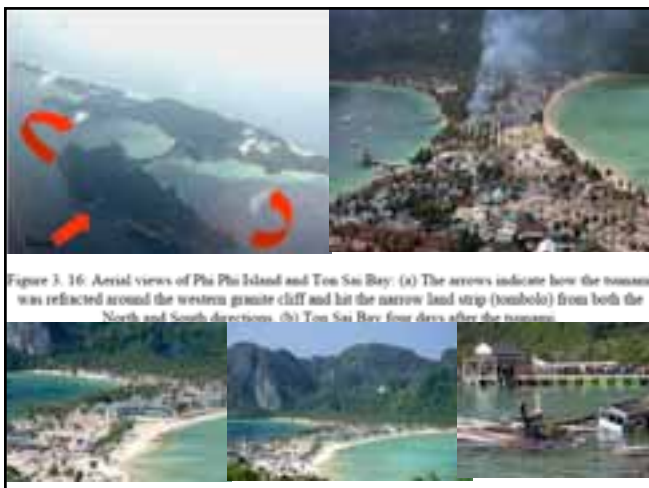
Figure 3.16: Aerial views of Phi Phi Island and Ton Sai Bay: (a) The arrows indicate how the tsunami was refracted around the western granite cliff and hit the narrow land strip (tombolo) from both the North and South directions. (b) Ton Sai Bay four days after the tsunami.

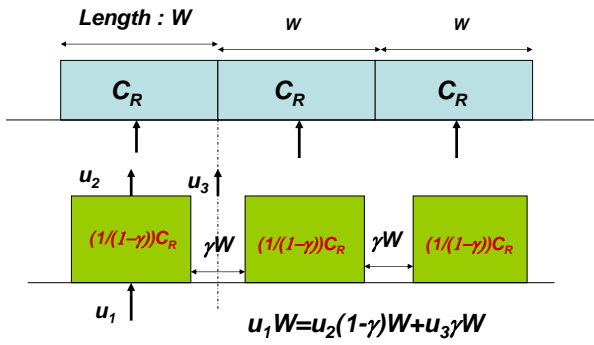
Effect of Greenbelt Arrangement

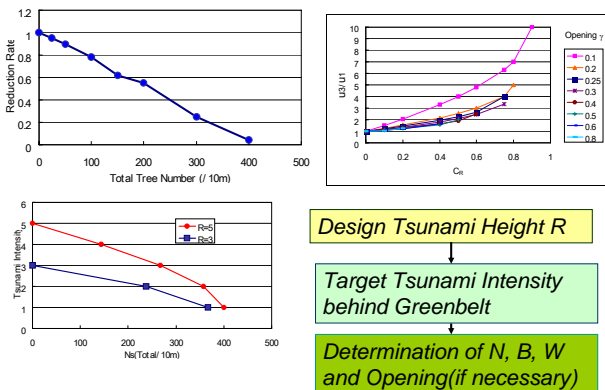
Design of Greenbelt

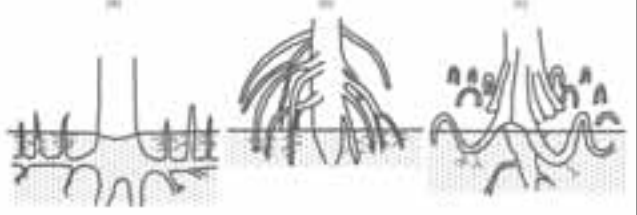
Figure 2.14 Schematic illustrations of types of roots in mangroves: (a) stilt roots as found in *Avicennia* and *Sonneratia*, (b) buttress roots as found in *Rhizophora*, and (c) knee roots, as found in other *Rhizophora* spp.

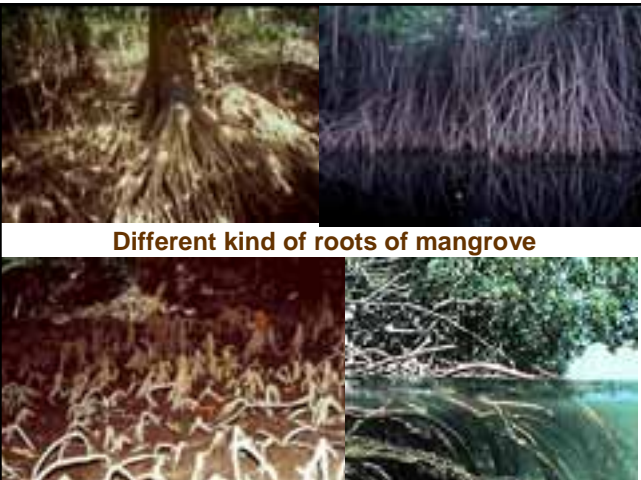
Mangrove roots form powerful limbs in open water.

Different kind of roots of mangrove

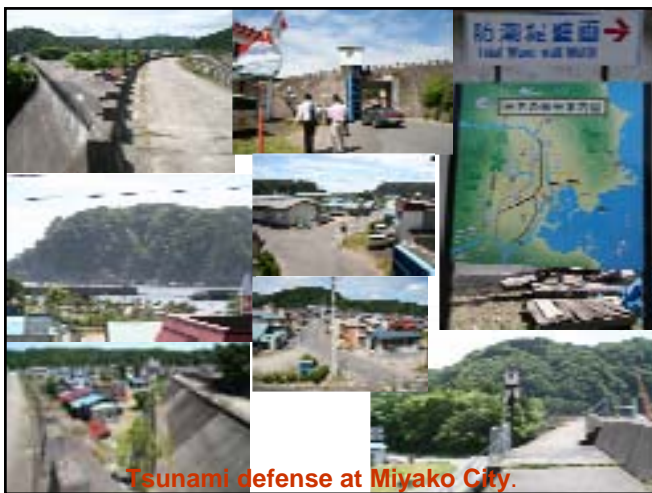
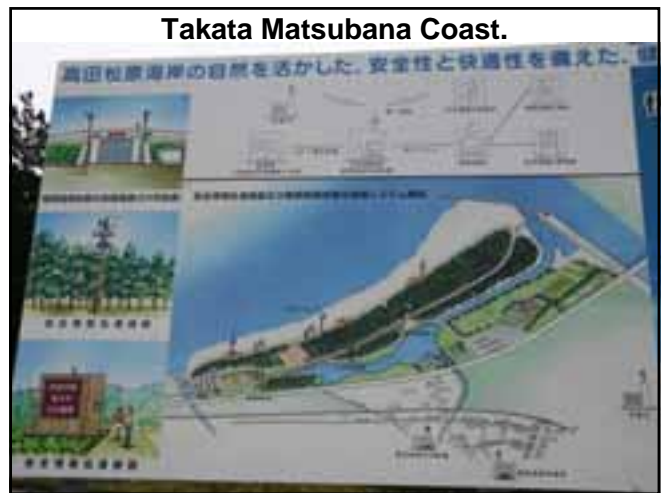
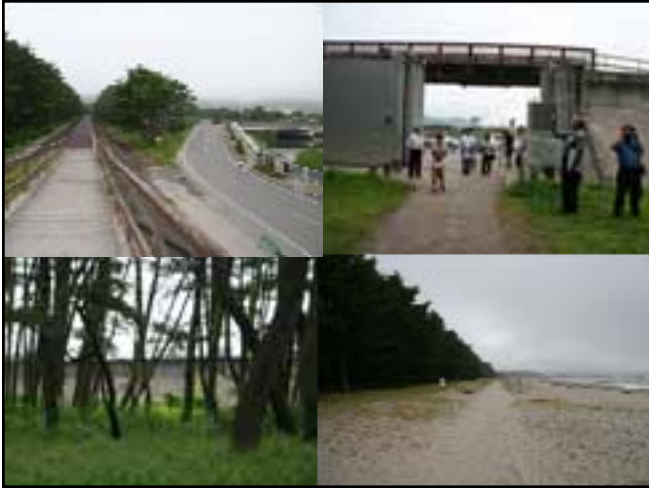
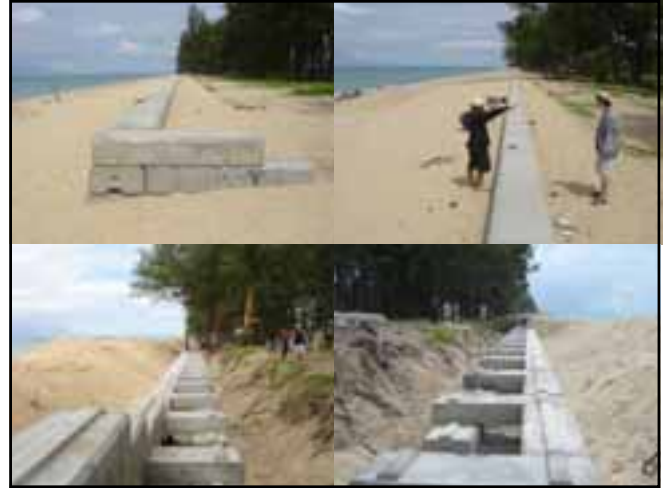
Breakwater at the mouth of a bay (Onagawa)

Floodgate (Shizugawa)

Tide embankment

Tsunami control forest

- ☐ Construction of breakwaters at the mouths of bays, and tide embankments
- ☐ Provision of floodgates at river mouths
- ☐ Tree planting for tsunami control forests behind tide embankments
