## Calliandra contour hedges Uganda - Orugo rwa Calliandra (Rukiga)

### Contour hedges of Calliandra planted on very steep slopes to combat soil erosion by decreasing surface runoff and increasing infiltration.

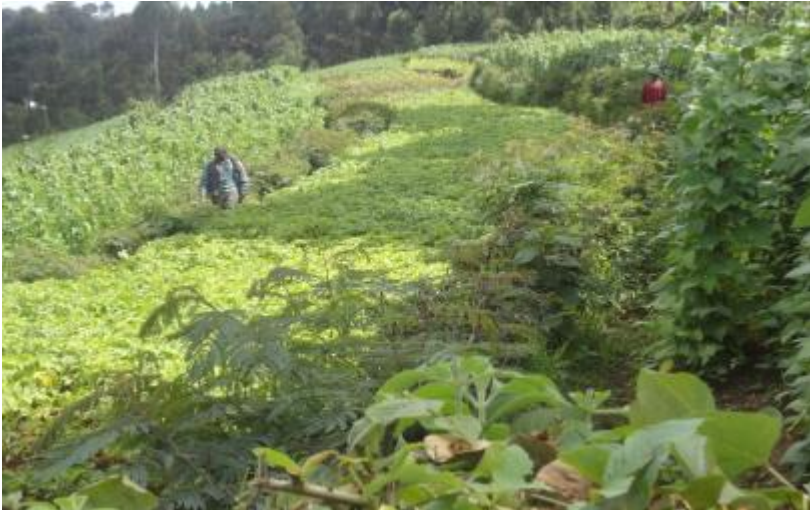
**left:** Calliandra hedgerow protecting soil by reducing runoff on a steep (35% to 60%) slope (Photo: Charles L Malingu)

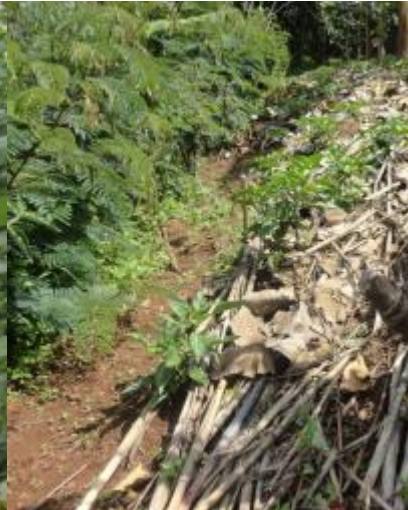
**right:** This technology is often supplemented with mulching, grass strips and agroforestry (Photo: Charles L Malingu)

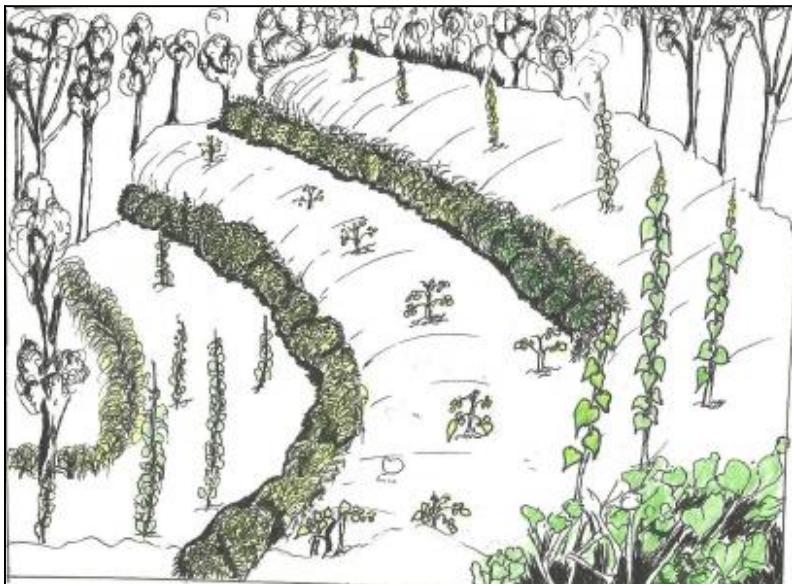
### Technical drawing

Calliandra trees are planted in rows along the contour. Cutting back is done between 12 and 18 months to a height of 0.5 m. The trees are allowed to grow to between 1 and 6 m and the hedge is maintained at that height. Gap-filling, weeding and trimming are critical for a productive hedge. (Byonabye, Prossy)

At the beginning of the rainy season, calliandra seedlings are transplanted from the nursery (0.2m to 0.3m height) and planted in a row (0.3m spacing). In the early stages, gap-filling with more seedlings may be necessary as some fail to get established. A mixture of top soil and manure is applied in the spaces between the seedlings and watering is done to improve the seedling survival rate. The distance between rows is 10 to 15 m and depends on the gradient of the slope. Establishment of hedges starts with construction of an earth banked terrace, creating a trench at the lower end of the terrace. Calliandra seedlings are planted on the higher side of the trench. Measuring off 10 m lengths upwards into the terrace, other rows of Calliandra seedlings are planted along the contour in order to achieve the inter-row spacing. Establishment is manual labor intensive and therefore the community, organized as Farmer Field Schools, participates in the planting, one field at a time. Simple tools such as hand hoes, sokajembe (pick-axe) and shovels are used. Maintenance is achieved by weeding, mulching and cutting back. For it to establish well, Calliandra needs to be weeded to minimize competition with weeds for water and nutrients. The weeds also harbour pests. It may also be necessary to mulch the area around each seedling during the dry season. Where mulching is done, the mulch is placed at least 0.05m away from the plant to reduce pest attacks. Calliandra calothyrsus trees are cut back at a height of 2m to between 0.15m and 1m to improve foliage which is used as fodder for livestock. The hedge is then maintained at a height of 1 to 6 m depending on the intended additional uses. The branches removed can be used as fuel wood or stakes, while leaves can be used as fodder.
