BASELINE STUDY
FOR
TRAINING IN SEA SAFETY DEVELOPMENT
PROGRAMME
IN EAST GODAVARI DISTRICT, ANDHRA PRADESH
INDIA

FOR
FOOD AND AGRICULTURE ORGANISATION
OF THE UNITED NATIONS
AND
DEPARTMENT OF FISHERIES, GOVT. OF ANDHRAPRADESH

BY
ACTION FOR FOOD PRODUCTION (AFPRO)
FIELD UNIT VI, HYDERABAD

BASELINE STUDY
November, 1997 – January, 1998

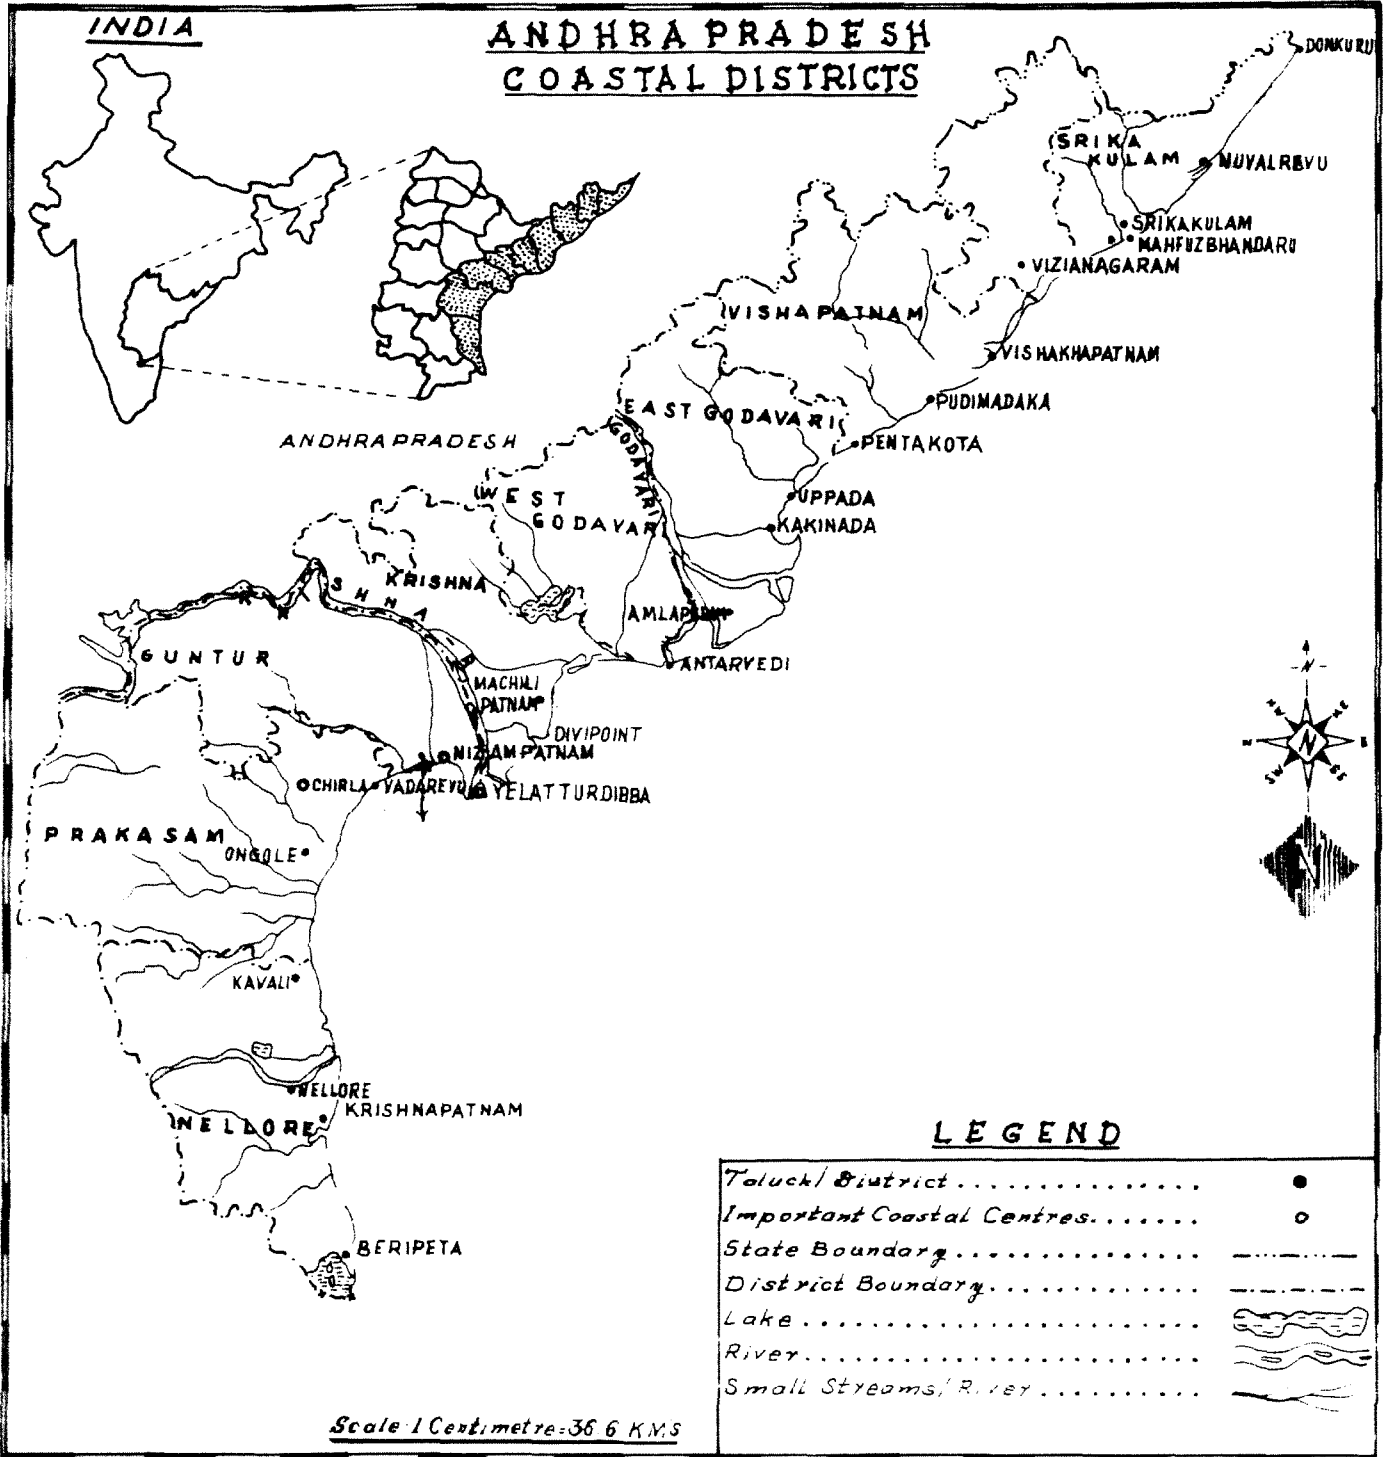
A low pressure area developed in Central Bay of Bengal off Ongole in the South Andhra Coast on 3rd/4th November 1996 at 16.4°N latitude and 90.4°E longitude (Fig. 1.1). The low-pressure area developed into a depression by 5th November and lay centered at 350Kms south east of Visakhapatnam. On the morning of November 6, 1996 it intensified into a severe cyclonic storm and was located 300Kms east of Machilipatnam. By 6th evening it further intensified into a much severe cyclonic storm with hurricane winds and crossed the coast of East Godavari district along the Gautami Godavari river mouth south of Kakinada, between

2000 to 2400 hours on 6th November, 1996. The wind speeds were reported to be upto 220Km/hour and storm surge 2.2m or even higher.

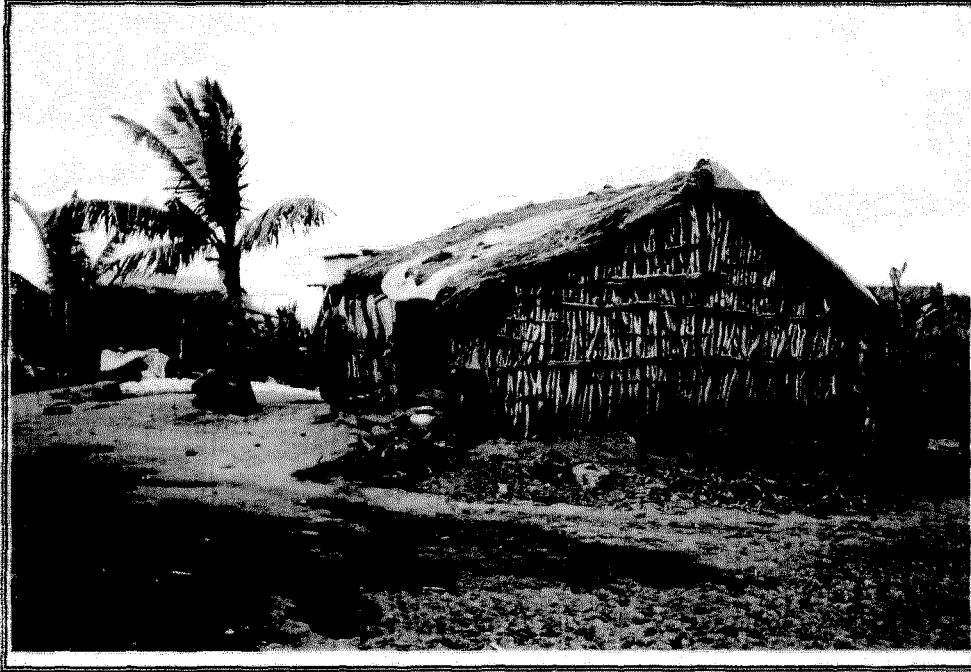
Plate II

Typical Thatched House - Bhairavapalem

As can be seen from the following table, based on the present survey almost all thatched houses had been severely damaged both due to the tidal surge of about 1.6 to 1.9 meters in various parts of the village (lasted for about one hour or less) and the high wind speed that had blown away the roofs. The heavy winds also blew away the roofs of most tiled houses and sunshades & window panes of some concrete houses.

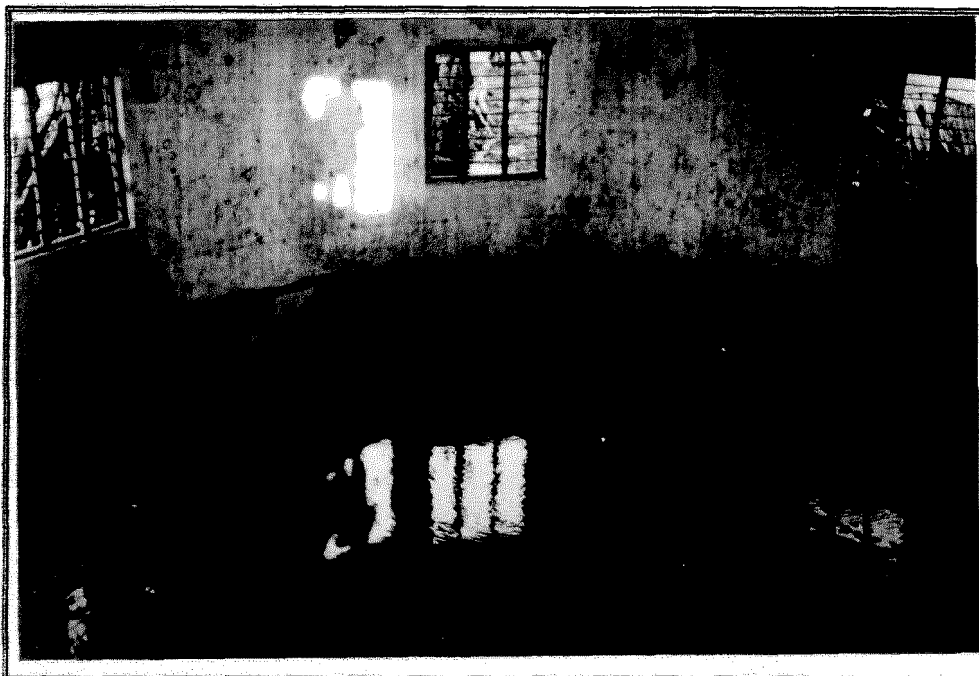
Plate IV

Inside The Cyclone Shelter ?!

There is one cyclone shelter in the whole village built with support of the Red Cross Society in 1980-81. The cyclone shelter is in a dilapidated condition with much of the steel rods exposed in the concrete, railings and part of the steps gone. The floor of the ground floor has completely sunk and it was in water logged condition. Naturally no one dared to take shelter in the building during the November 6, 1996 Cyclone.

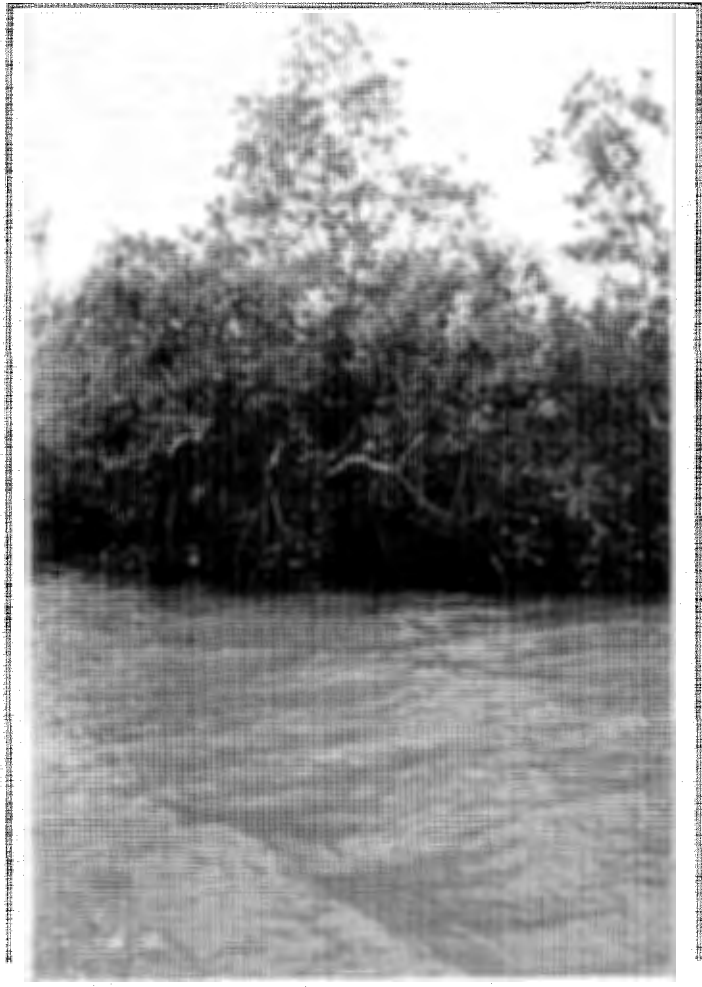
Mangroves, which saved lives during tidal surge Plate VI

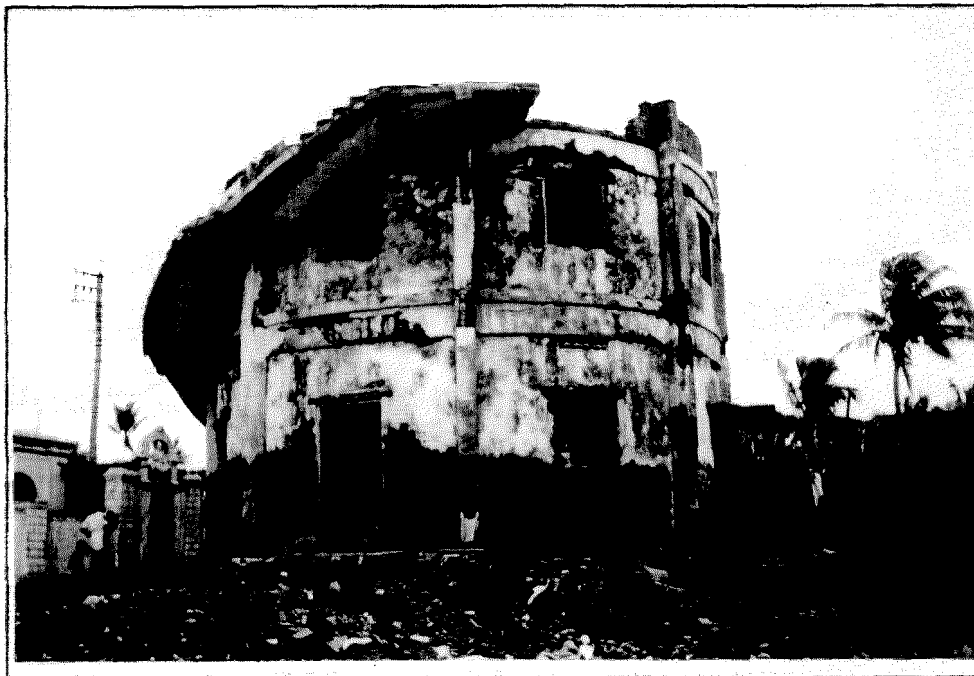
Plate VII

Condition Of Cyclone Shelter at Paturu, Bahusutippa

There are 3 cyclone shelters in the village. 2 of the cyclone shelters are old (1981) and are in Madyapeta and Paturu. Both these shelters are very much in dilapidated condition and no one did take shelter in these shelters during the cyclone. It was surprising to find that the ground floor of one of the shelters was housing a temporary liquor shop.

We have seen earlier that 95% of the houses in Paturu are thatched and now that the only cyclone shelter in Paturu is in a dilapidated condition. The third cyclone shelter in Kothapeta was built in 1988 and is in a better condition. Some fisherfolk did take shelter here during the cyclone.

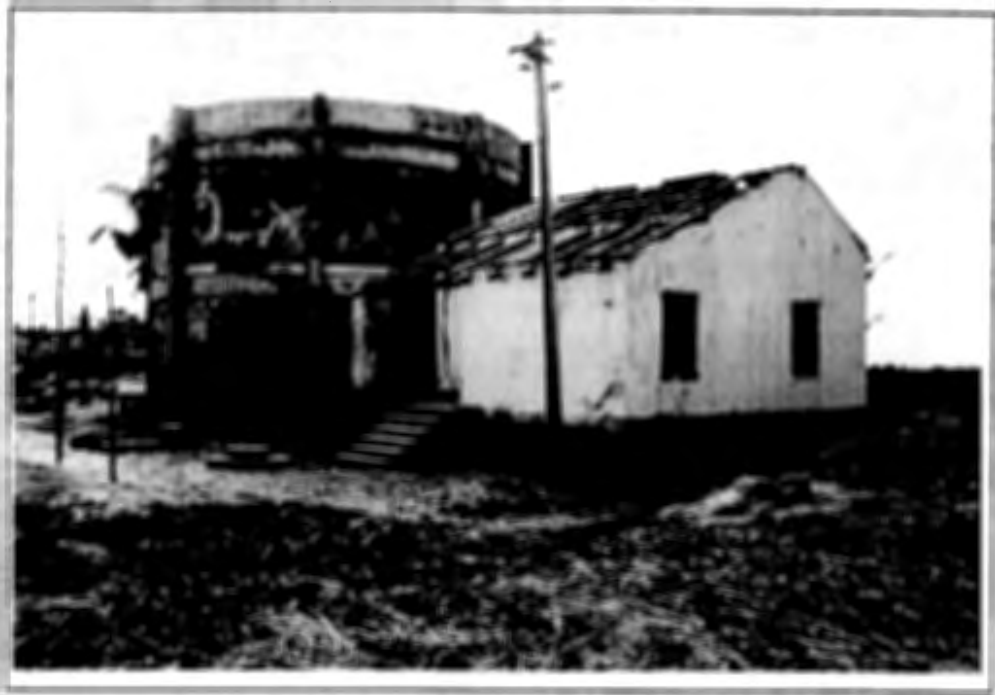
Plate X

Dilapidated Cyclone Shelter and Damaged School Building

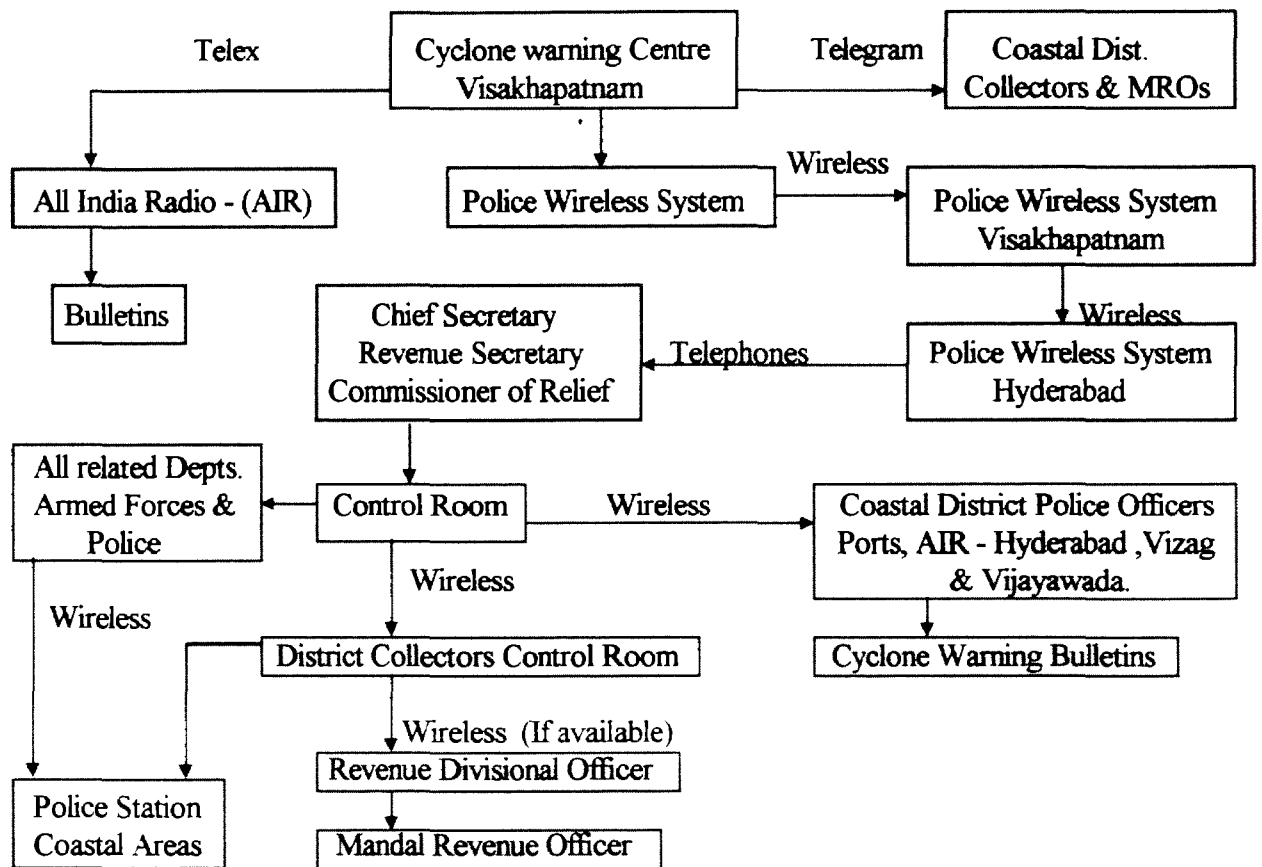
Fig 6.2 Path of cyclone warning dissemination

The information on the formation, path, intensity and speed of cyclones is detected and informed by the Cyclone Warning Centre, Visakhapatnam. This centre is directly under the control of the Area Cyclone Warning Centre (ACWC), Madras. The main path of the Warning System is shown in Fig 6.2. The stages of warnings are:

- First Stage: As the Cyclonic storm is located.
- Second Stage: - Cyclonic warning 60-90 Kmph
- Severe Cyclone 90-120Kmph
- Hurricane > 120Kmph
- The All India Radio will continue to give more frequent warning bulletins as the stages go upward. This will be broadcast by Hyderabad, Visakhapatnam and Vijayawada Stations.
- Ports to be informed by landline telegrams. Ports to hoist visual signs, during day and lights by night.
- Fisheries Officers of the Coastal district to be informed directly by the Storm Warning Centre by high priority land line telegrams.
- Priority channel advised is the Police Wireless System.

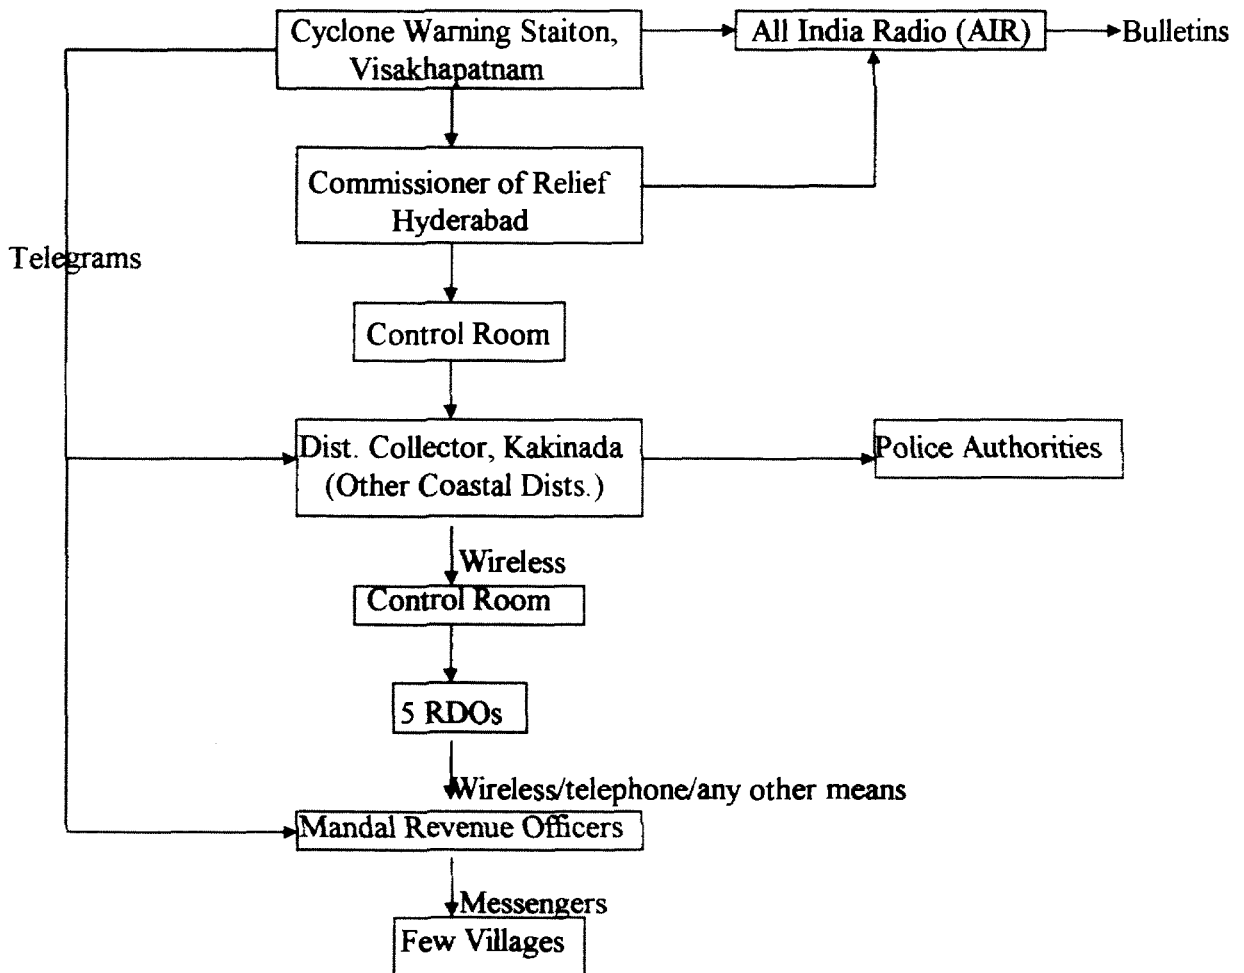
Fig.6.3 Cyclone Warning Dissemination Path Followed on 5th & 6th November 1996

We shall try to look into the cyclone warning dissemination on 5th and 6th of November 1996, taking the case of East Godavari district and specifically Bhairavapalem, Balusutippa and similar areas. The major path of communication followed is given Fig.6.3.

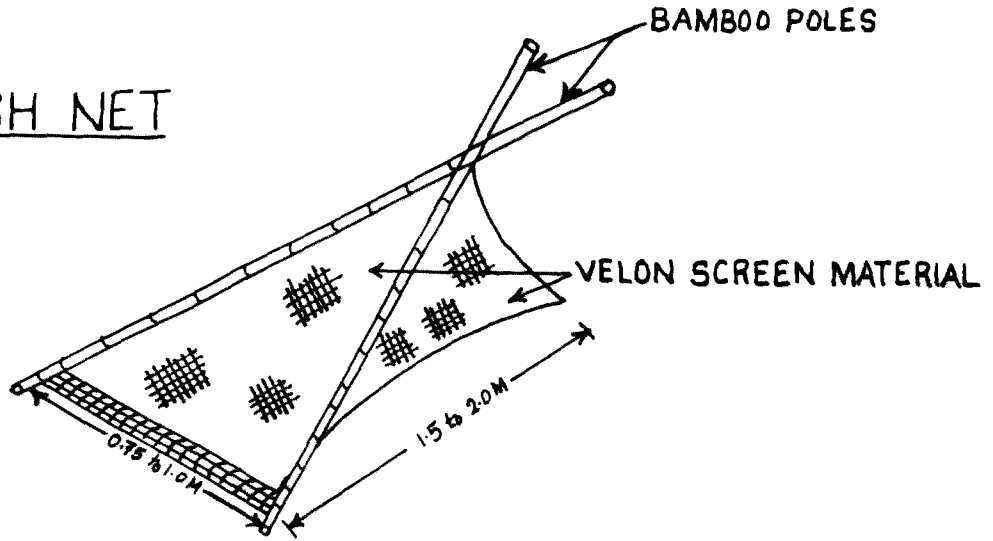
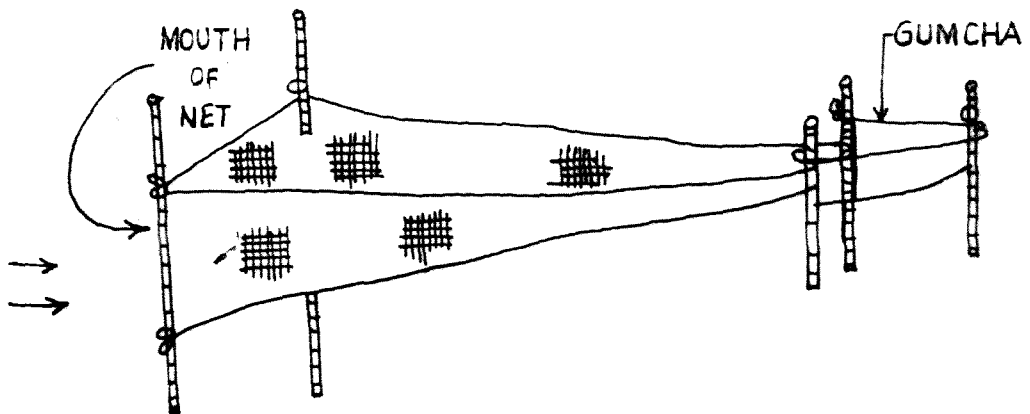
FIG A-9.1

GEARS FOR COLLECTING SHRIMP SEED

PUSH NET

SHOOTING NET

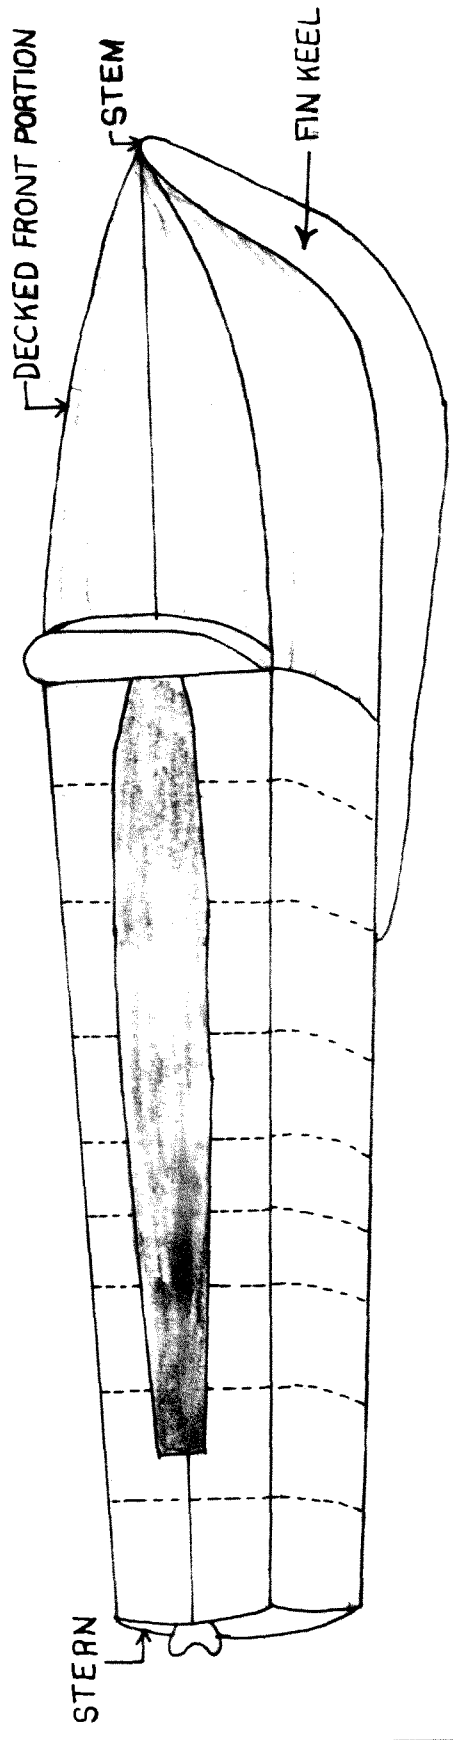
FIG A-10-1

SHOE DHONI OF EAST GODAVARI DISTRICT

SCALE : 2 CM = 1M

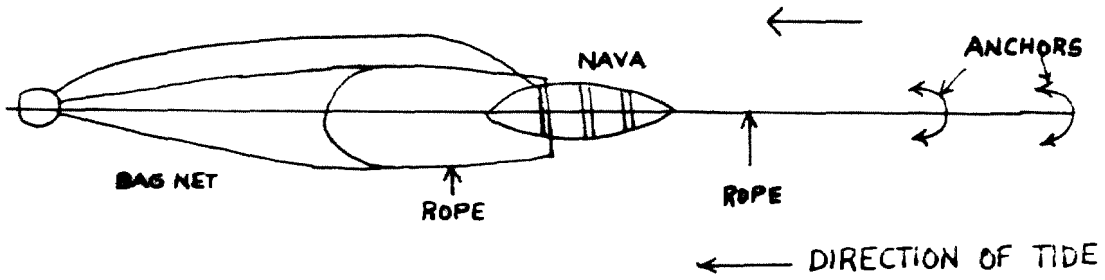
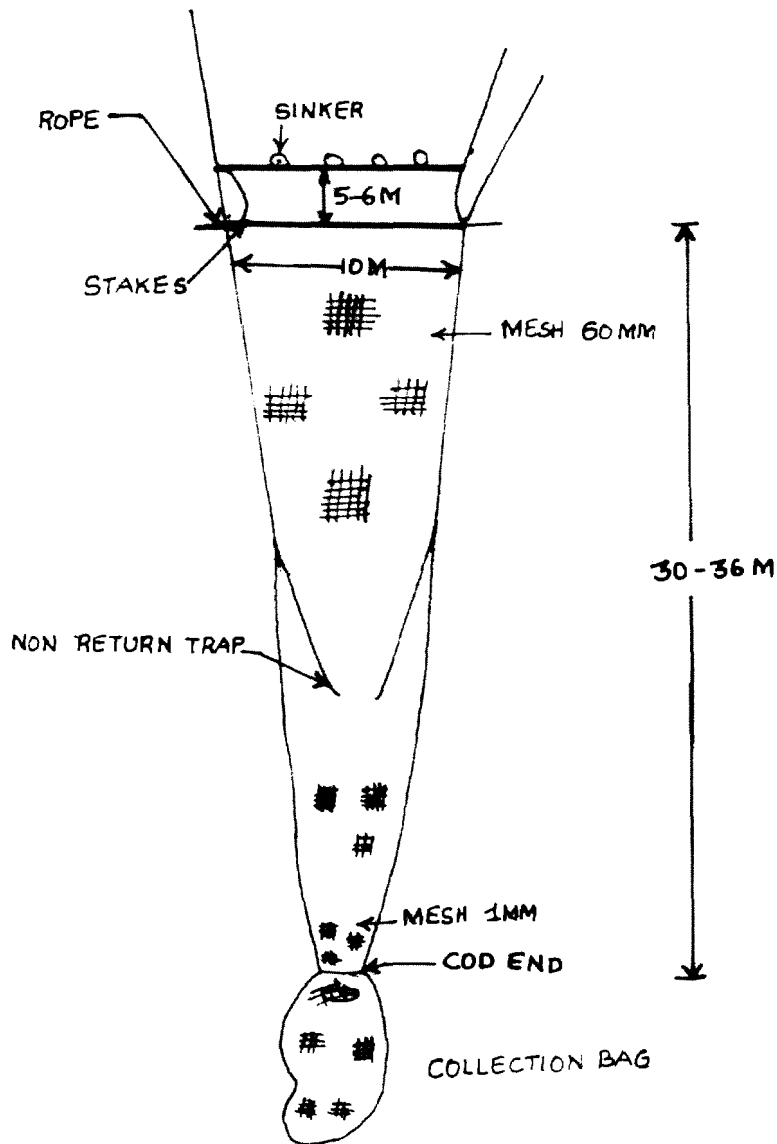
FIG A-10.2

LUNGER VALA OPERATION

(ASPER FISHERMENS DESCRIPTION)
