Theme 3 | Soil data for policy and decision-making

Assessing intra and extra channel contamination by iron ore tailings in Doce River Basin, Brazil

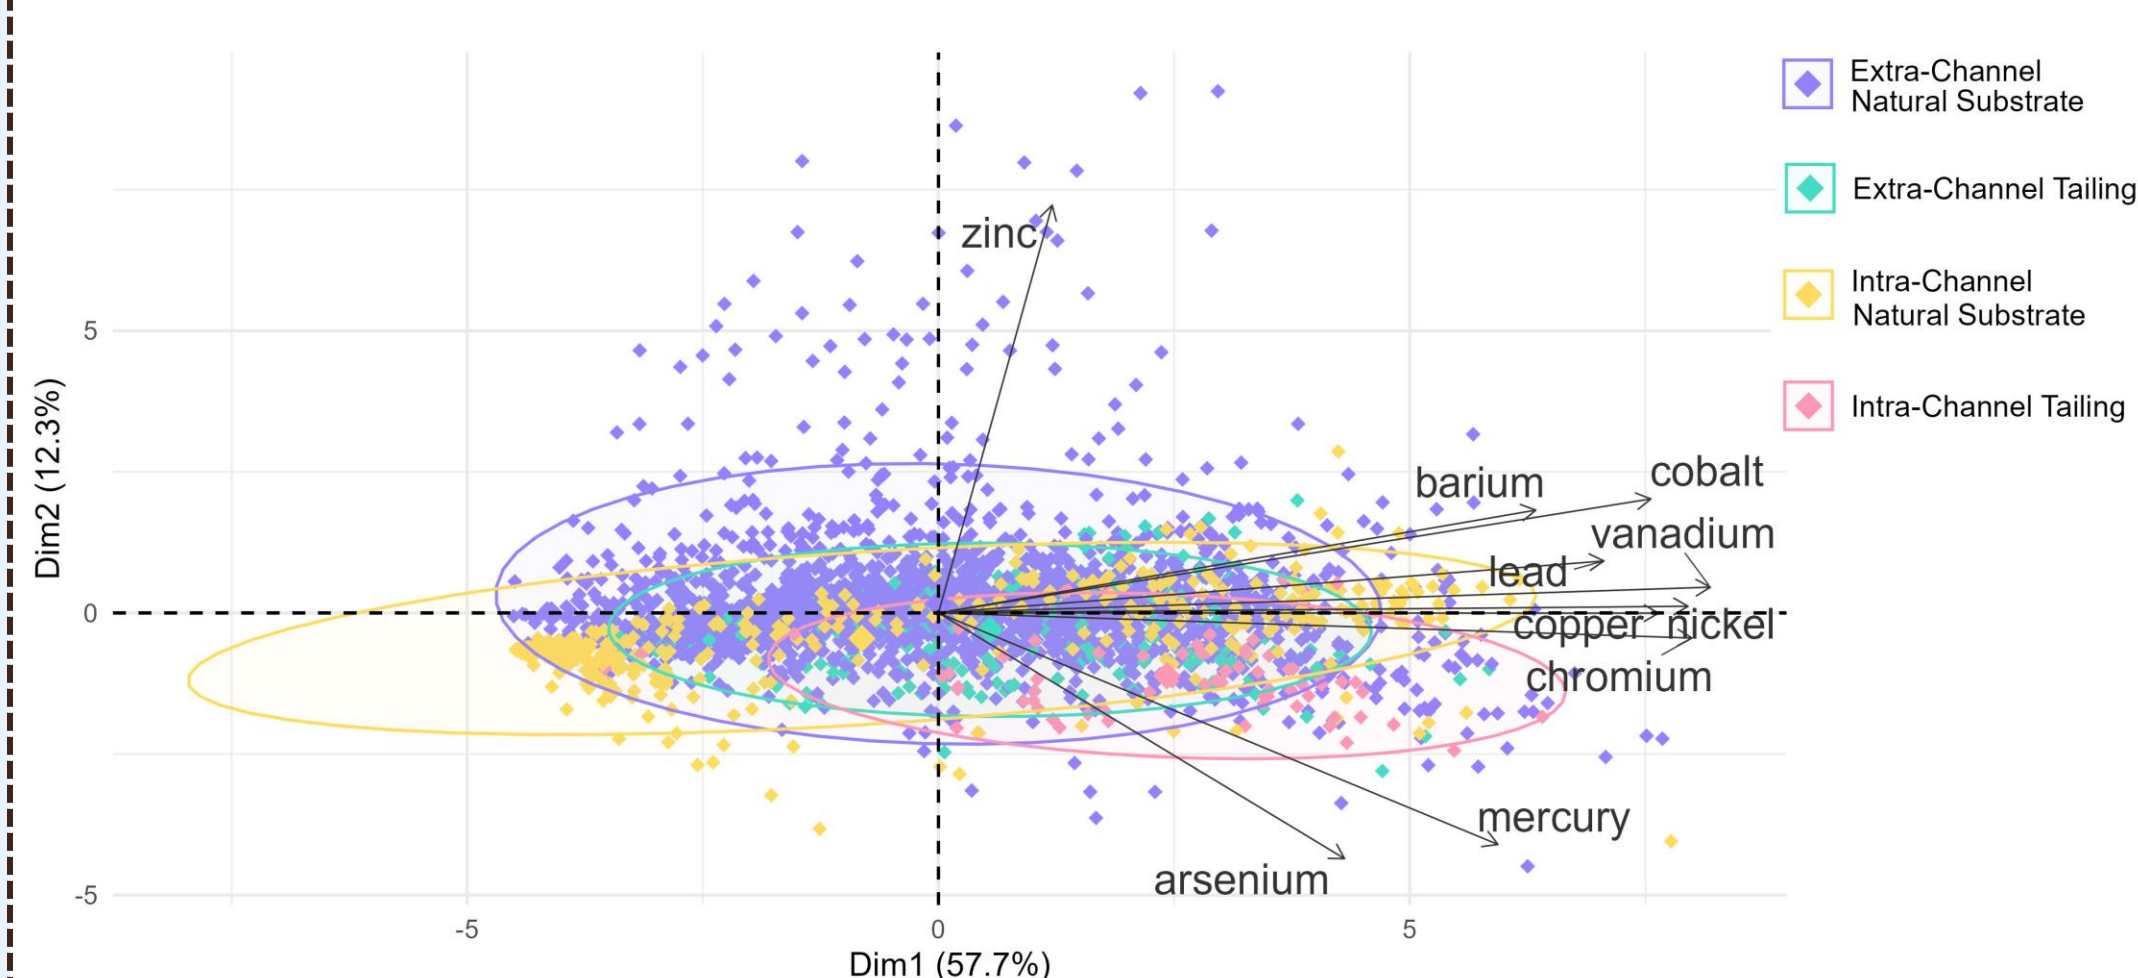
Fig.4: Principal Component Analysis - Biplot Graph.
