## APPENDIX 4

### *Investment Plan for the Development of Climate Resilient Fisheries Infrastructure in Grand Bahama and Abaco Islands (draft version)*

## Fishery Infrastructure Inventory of Grand Bahama and Abaco Islands

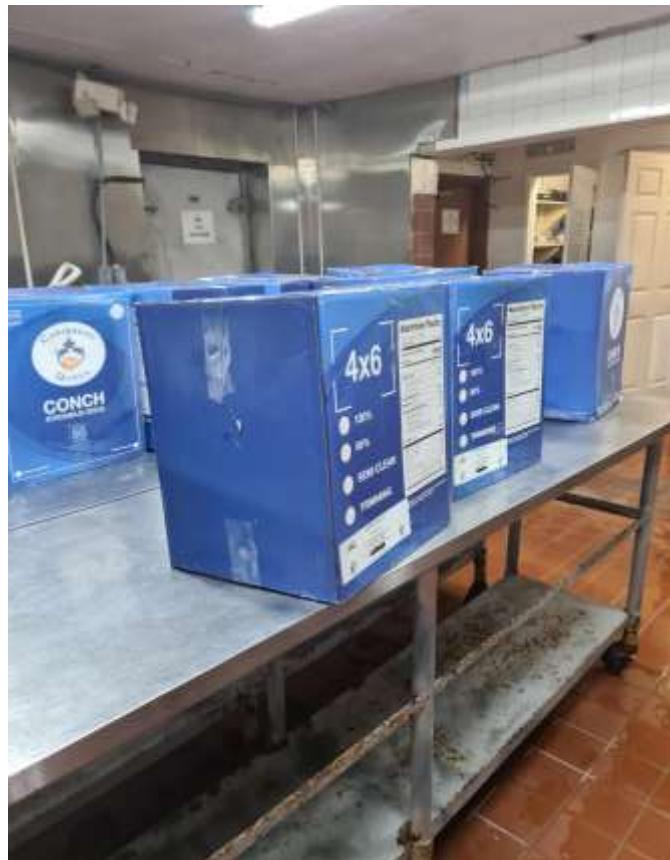
Figure 1 – Conch packaged for export.

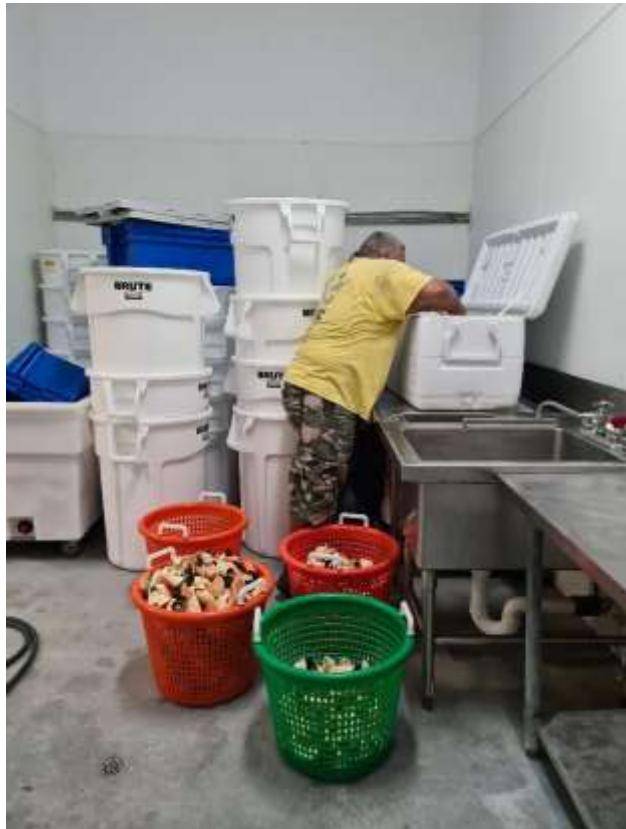
**Figure 1-** Staff processing stone crab.

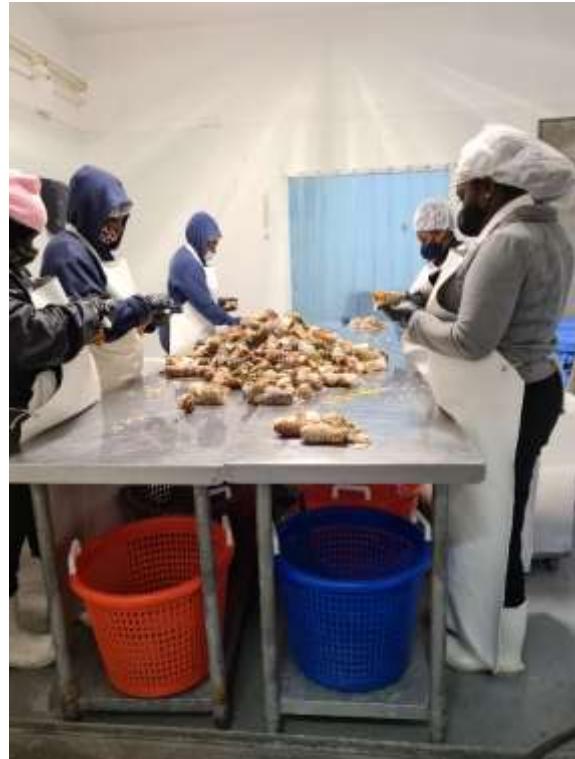
**Figure 2-** Staff processing spiny lobster.

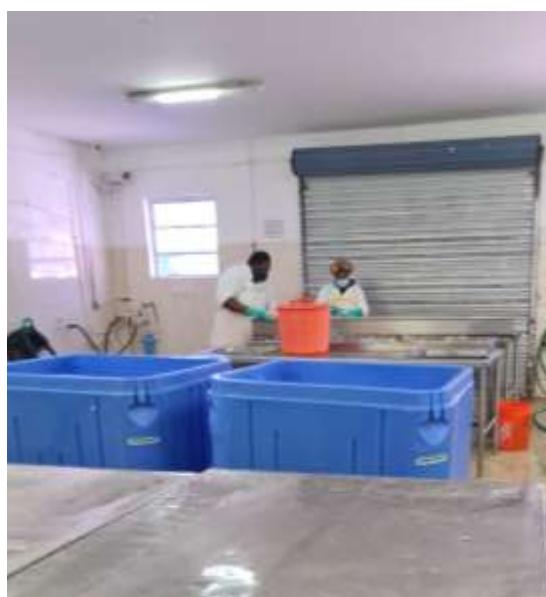
**Figure 2-** Staff of G & L processing conch to export.

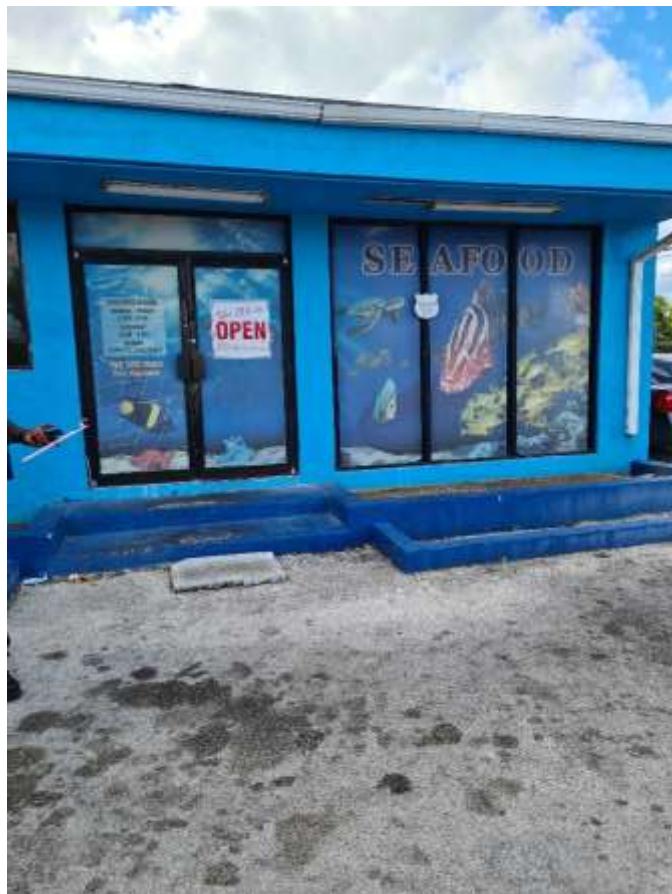
**Figure 1-** The exterior of Lightbourne Seafood.

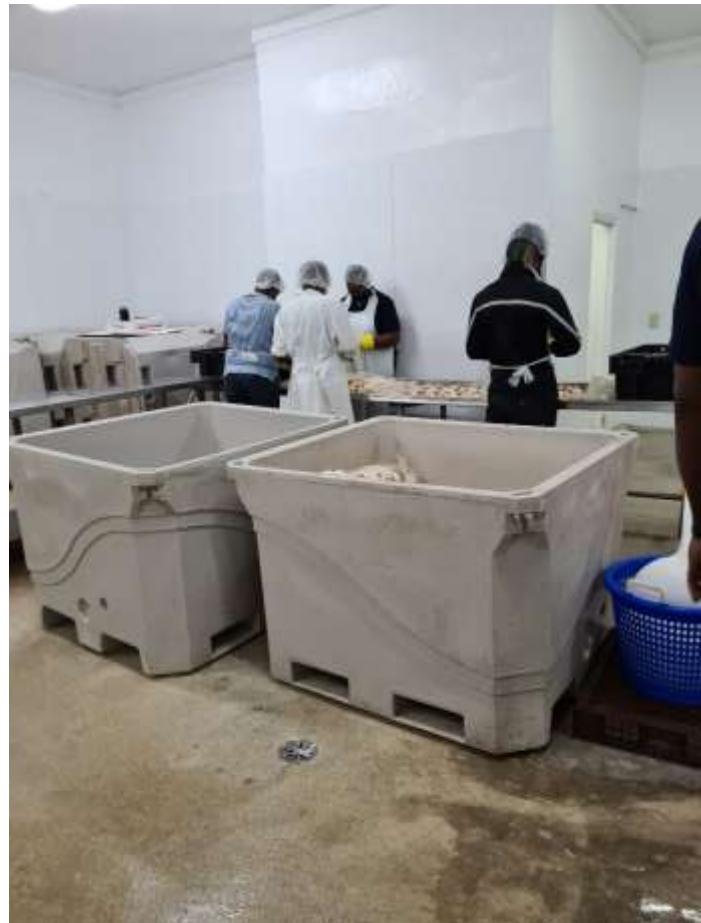
**Figure 2-** Staff processing Queen Conch.

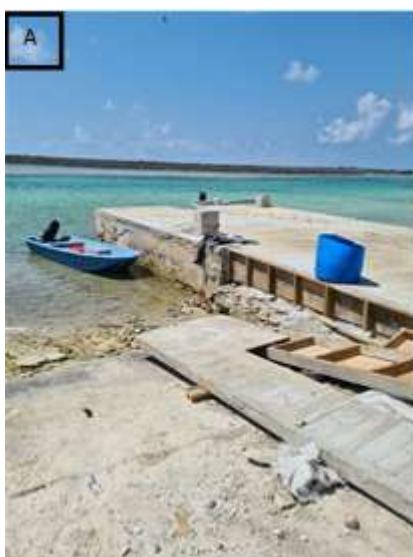
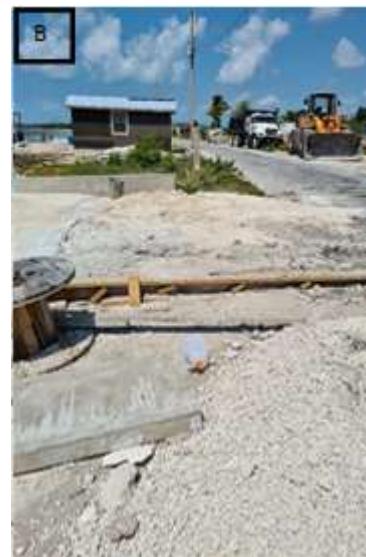
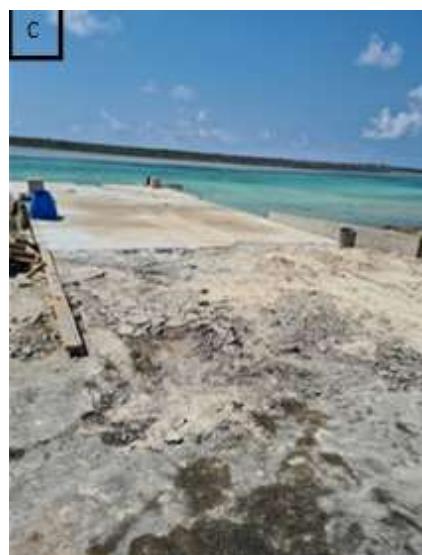
TYPE	EXISTING	DAMAGED	PROPOSED	OUTLINE COST U\$
Breakwater	-			0.00
Quay wall	-			0.00
Jetty on piles	Yes	Yes	Repair	0.00
Slipway	Yes	Yes	Repair	0.00
Gear Stores	-			0.00
Net repair shed	-			0.00
Engine repair	-			0.00
Fish sales Hall	-			0.00
Admin building	-			0.00
Cool Store	-			0.00
Ice maker	-			0.00
Water Tanks	-			0.00
Fuel Tanks	-			0.00
Septic Tanks	-			0.00
Equipment	-			0.00

Figure 1 – Main dock in Sweeting's Cay (Private)

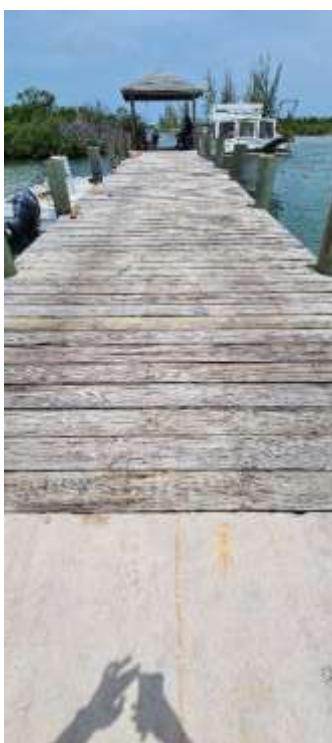
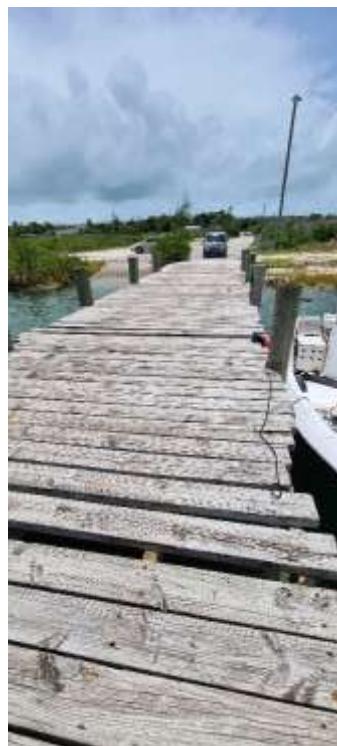
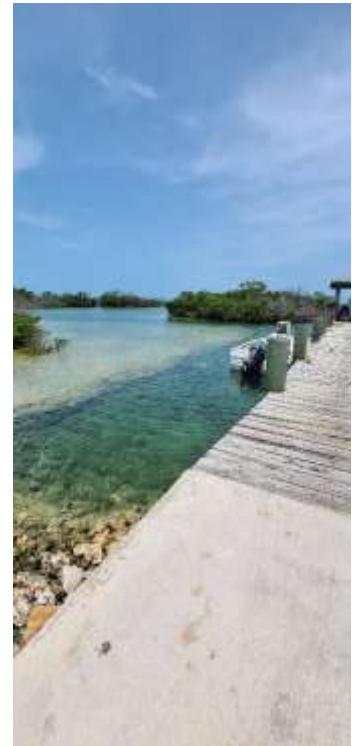
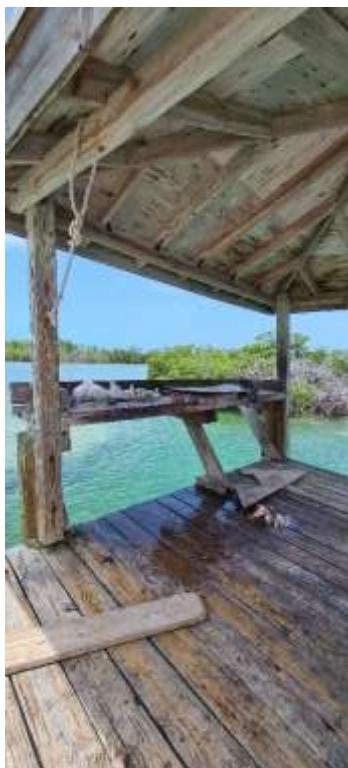
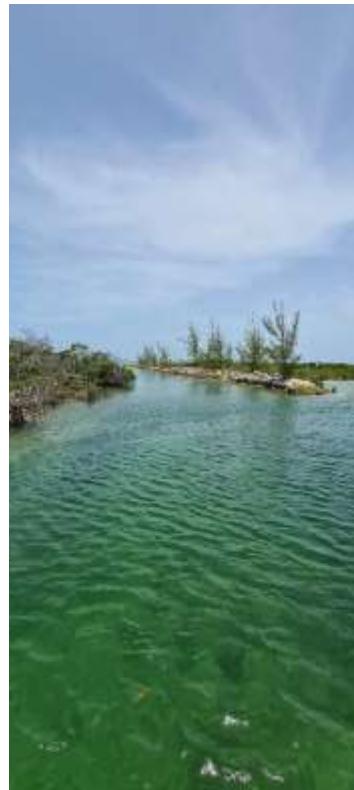
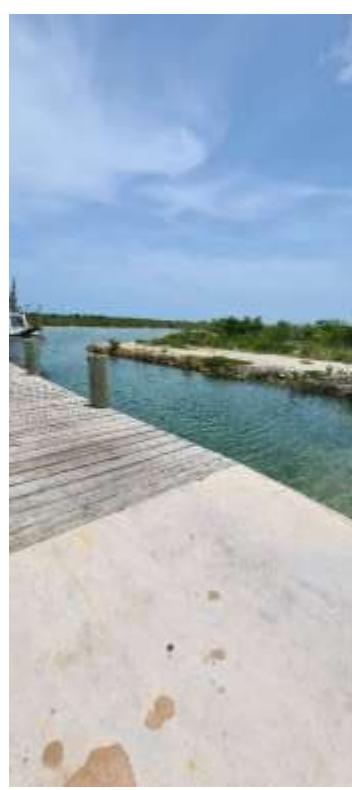
## FIELD PHOTOS OF STRUCTURES

TYPE	EXISTING	DAMAGED	PROPOSED	OUTLINE U\$	COST
Breakwater	No				0.00
Quay wall	No				0.00
Jetty on piles	Yes	Yes			0.00
Slipway	Yes	Yes			0.00
Gear Stores	No				0.00
Net repair shed	No				0.00
Engine repair	No				0.00
Fish sales Hall	No				0.00
Admin building	No				0.00
Cool Store	No				0.00
Ice maker	No				0.00
Water Tanks	No				0.00
Fuel Tanks	No				0.00
Septic Tanks	No				0.00
Equipment	No				0.00

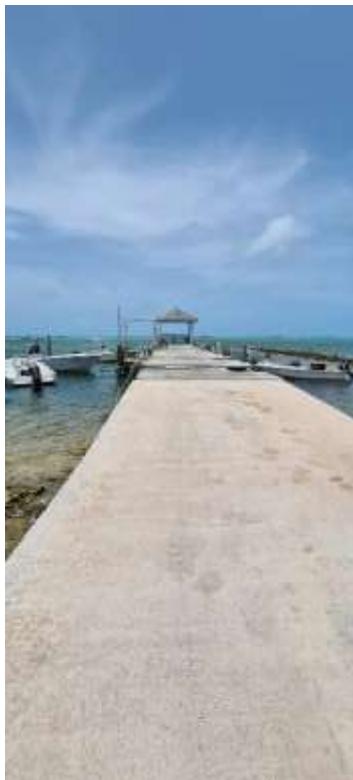
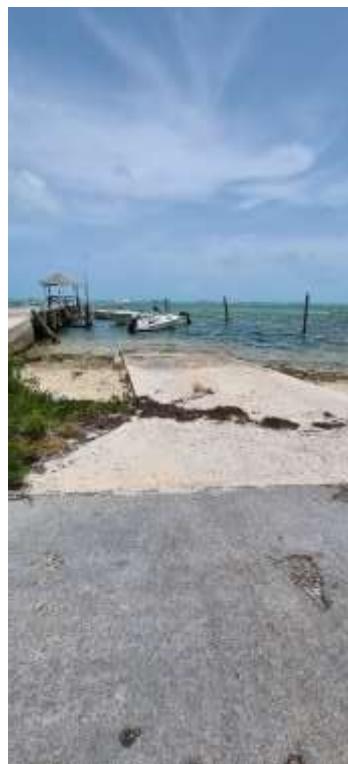
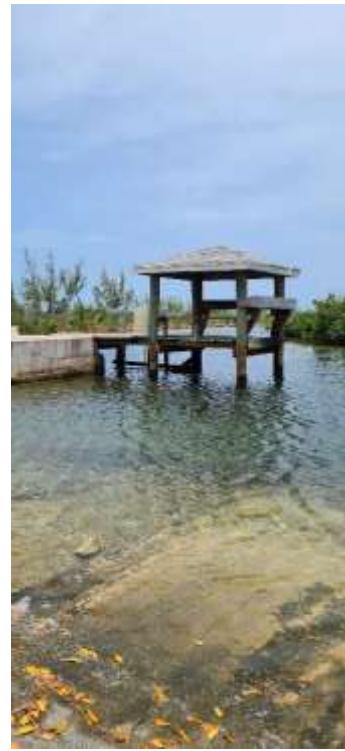
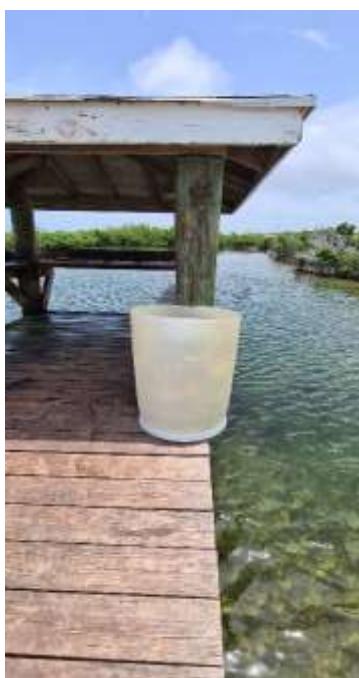
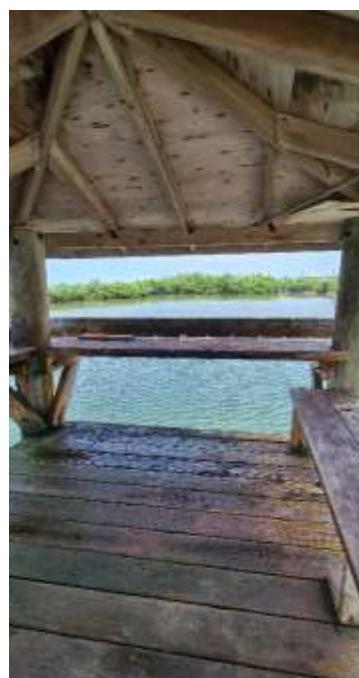
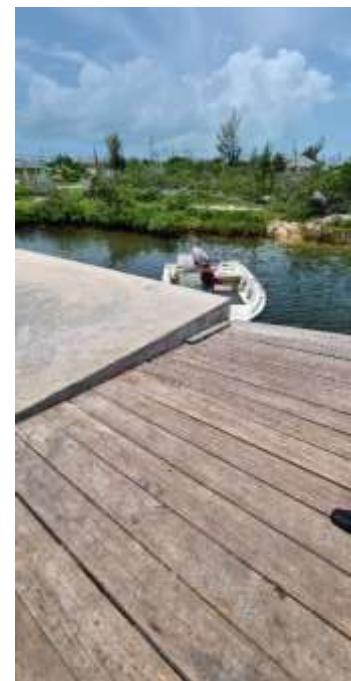
### FIELD PHOTOS OF STRUCTURES

TYPE	EXISTING	DAMAGED	PROPOSED	OUTLINE COST US\$
Breakwater	Yes	No		0.00
Quay wall	No			0.00
Jetty on piles	Yes	Yes		0.00
Slipway	Yes	Yes		0.00
Gear Stores	No			0.00
Net repair shed	No			0.00
Engine repair	No			0.00
Fish sales Hall	No			0.00
Admin building	No			0.00
Cool Store	No			0.00
Ice maker	No			0.00
Water Tanks	No			0.00
Fuel Tanks	No			0.00
Septic Tanks	No			0.00
Equipment	No			0.00

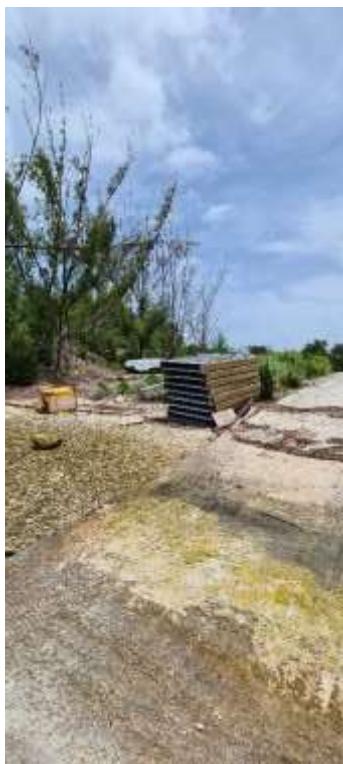
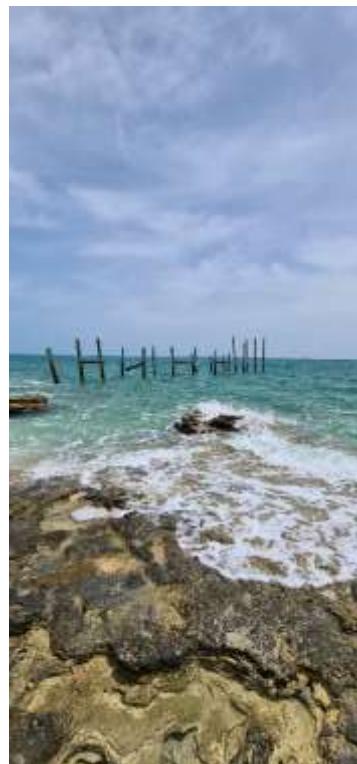
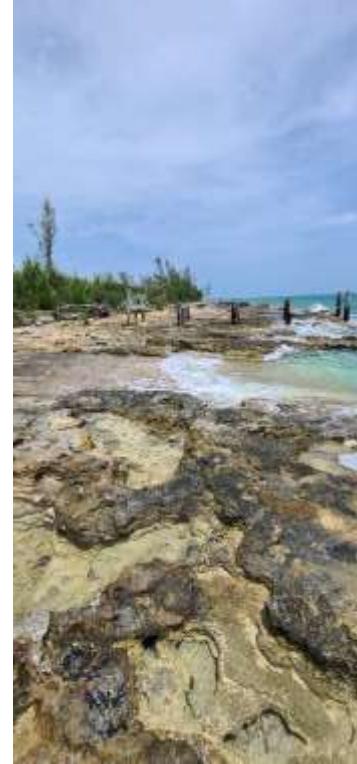
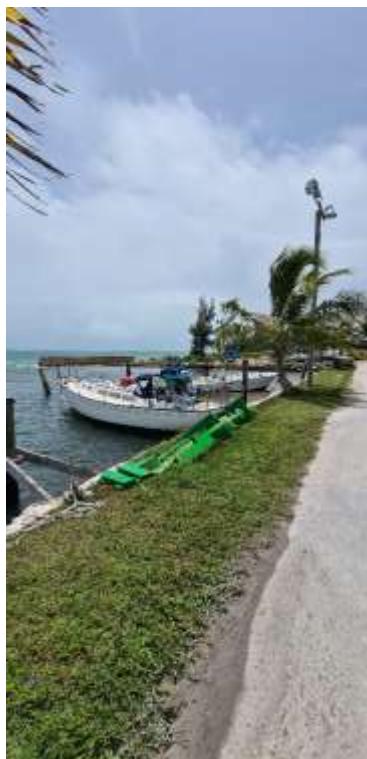
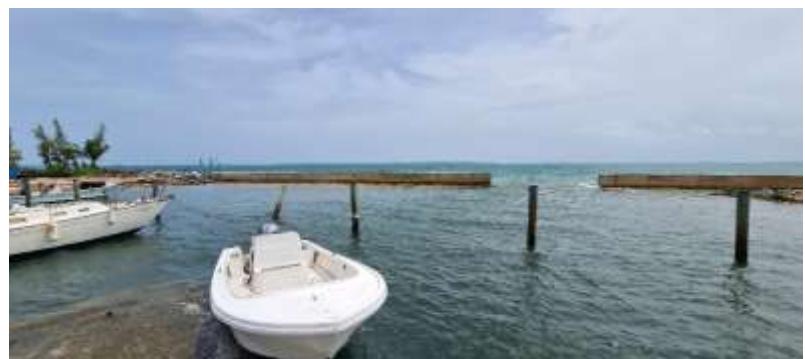
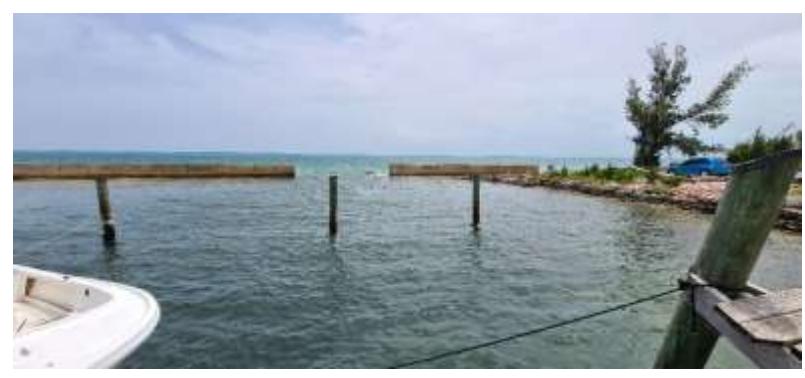
## FIELD PHOTOS OF STRUCTURES

TYPE	EXISTING	DAMAGED	PROPOSED	OUTLINE U\$	COST
Breakwater	No				0.00
Quay wall	No				0.00
Jetty on piles	Yes	Yes			0.00
Slipway	Yes	Yes			0.00
Gear Stores	No				0.00
Net repair shed	No				0.00
Engine repair	No				0.00
Fish sales Hall	No				0.00
Admin building	No				0.00
Cool Store	No				0.00
Ice maker	No				0.00
Water Tanks	No				0.00
Fuel Tanks	No				0.00
Septic Tanks	No				0.00
Equipment	No				0.00

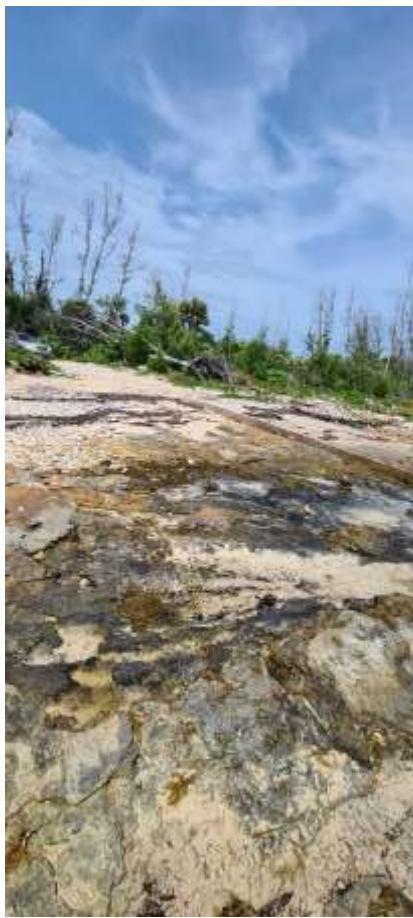
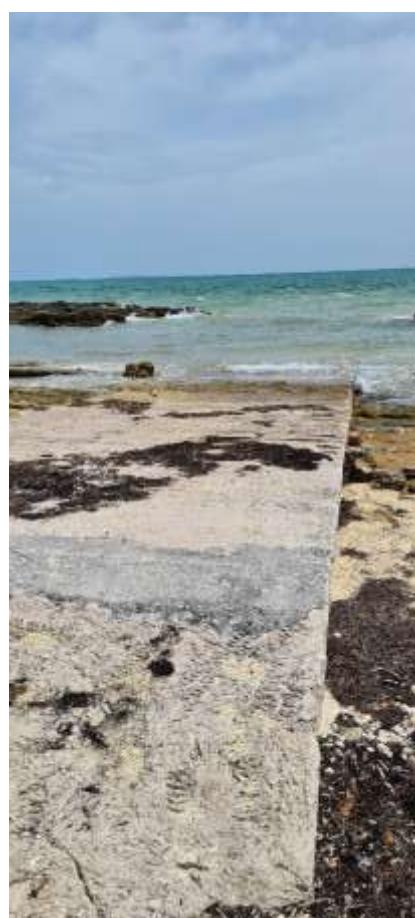
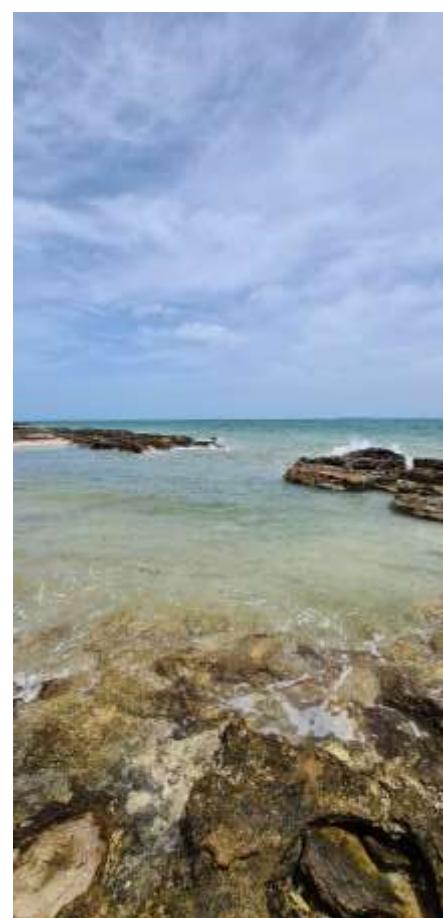
## FIELD PHOTOS OF STRUCTURES

TYPE	EXISTING	DAMAGED	PROPOSED	OUTLINE COST U\$
Breakwater	No			0.00
Quay wall	No			0.00
Jetty on piles	Yes	Yes		0.00
Slipway	Yes	Yes		0.00
Gear Stores	No			0.00
Net repair shed	No			0.00
Engine repair	No			0.00
Fish sales Hall	No			0.00
Admin building	No			0.00
Cool Store	No			0.00
Ice maker	No			0.00
Water Tanks	No			0.00
Fuel Tanks	No			0.00
Septic Tanks	No			0.00
Equipment	No			0.00

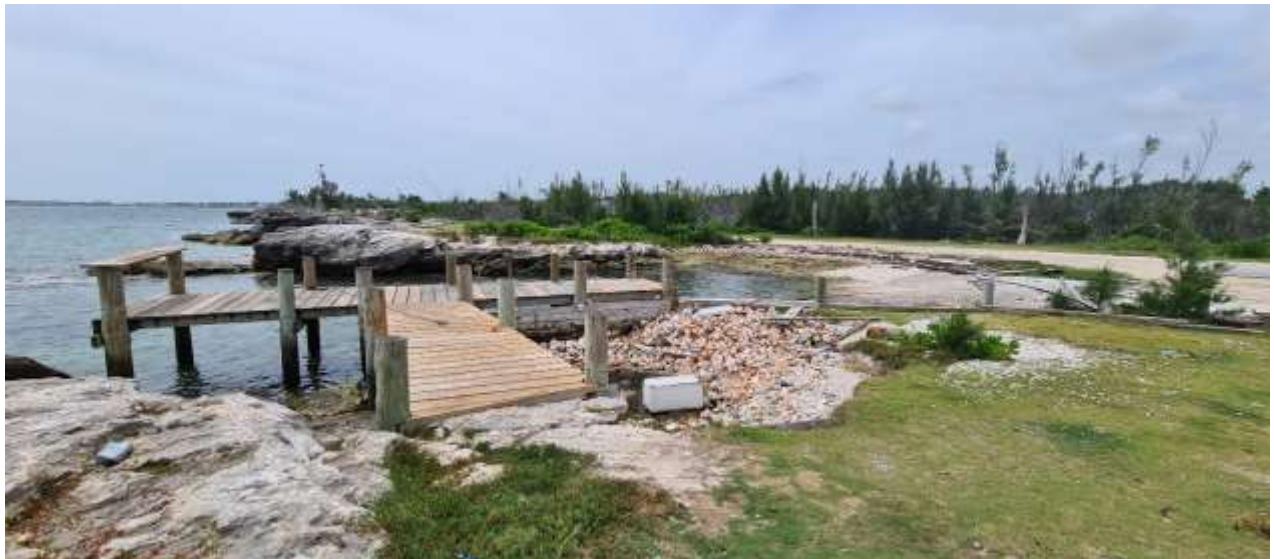
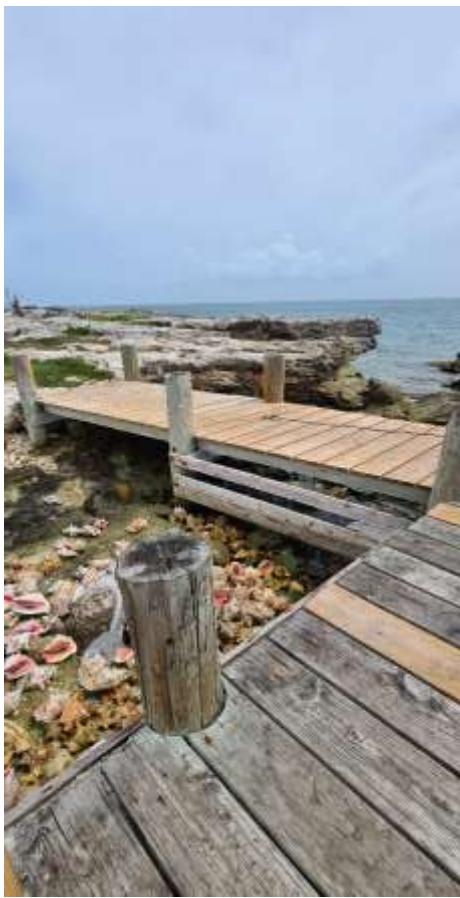
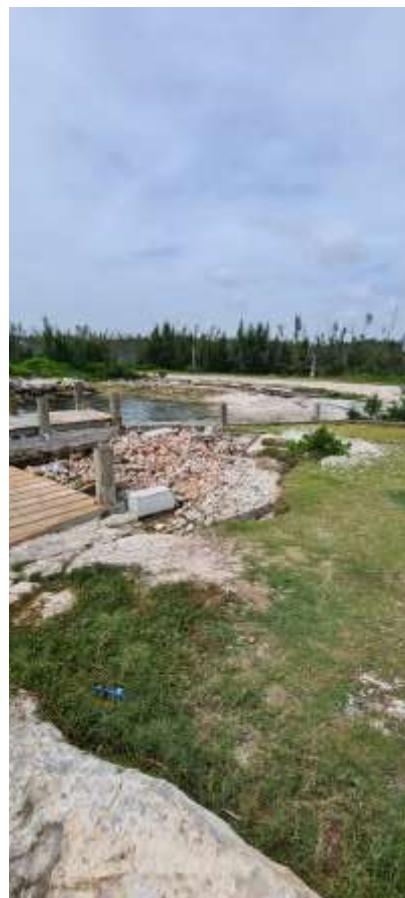
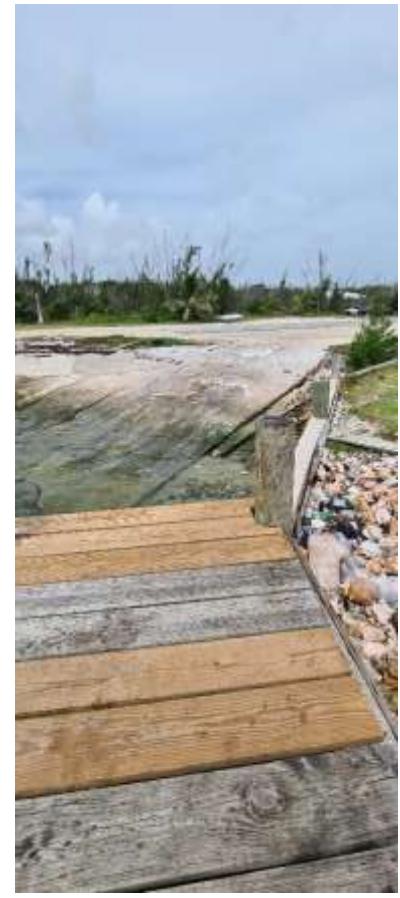
## FIELD PHOTOS OF STRUCTURES

TYPE	EXISTING	DAMAGED	PROPOSED	OUTLINE COST U\$
Breakwater	No			0.00
Quay wall	No			0.00
Jetty on piles	Yes	Yes		0.00
Slipway	Yes	Yes		0.00
Gear Stores	No			0.00
Net repair shed	No			0.00
Engine repair	No			0.00
Fish sales Hall	No			0.00
Admin building	No			0.00
Cool Store	No			0.00
Ice maker	No			0.00
Water Tanks	No			0.00
Fuel Tanks	No			0.00
Septic Tanks	No			0.00
Equipment	No			0.00

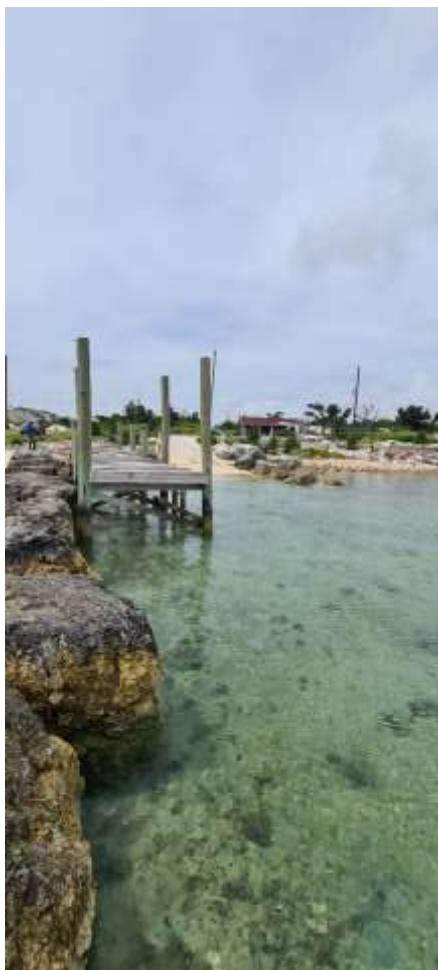
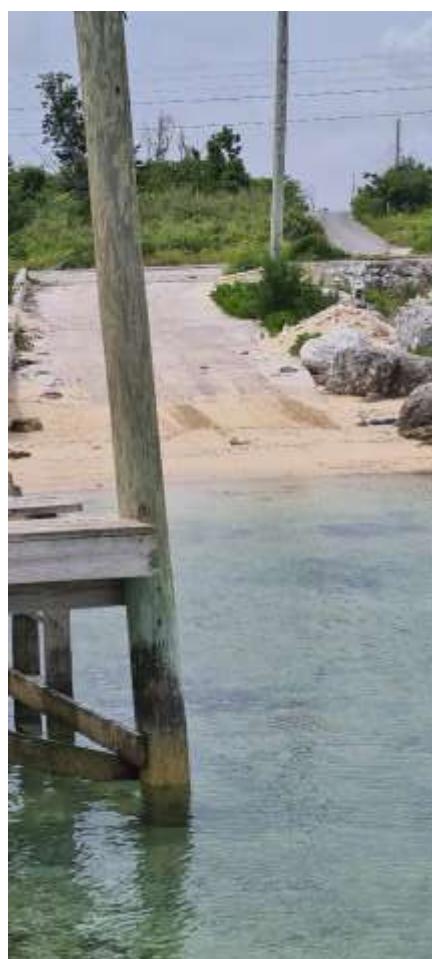
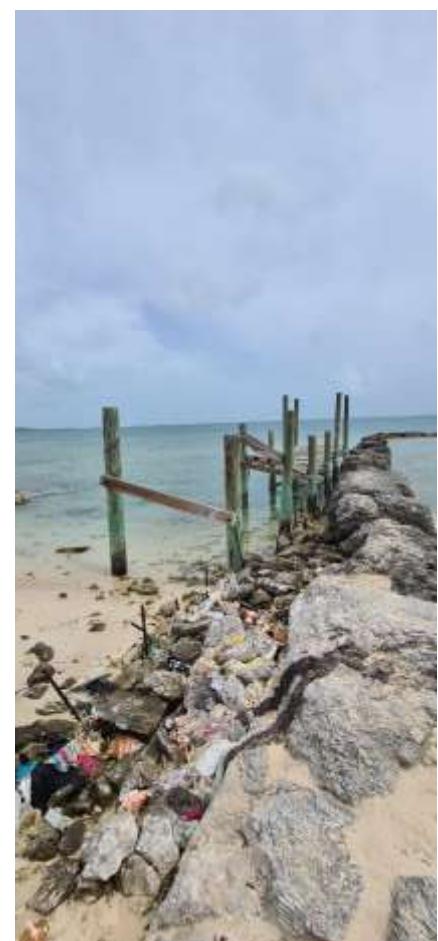
## FIELD PHOTOS OF STRUCTURES

TYPE	EXISTING	DAMAGED	PROPOSED	OUTLINE COST U\$
Breakwater	No			0.00
Quay wall	Yes	No		0.00
Jetty on piles	Yes	Yes		0.00
Slipway	Yes	Yes		0.00
Gear Stores	No			0.00
Net repair shed	No			0.00
Engine repair	No			0.00
Fish sales Hall	No			0.00
Admin building	No			0.00
Cool Store	No			0.00
Ice maker	No			0.00
Water Tanks	No			0.00
Fuel Tanks	No			0.00
Septic Tanks	No			0.00
Equipment	No			0.00

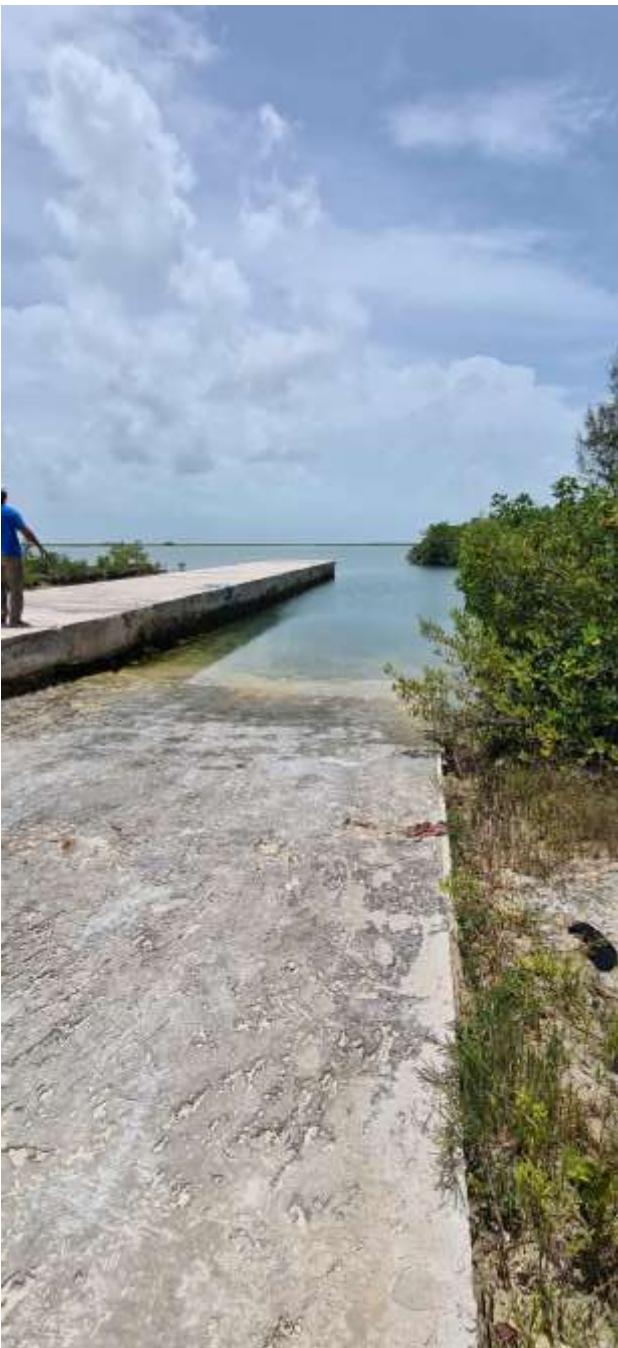
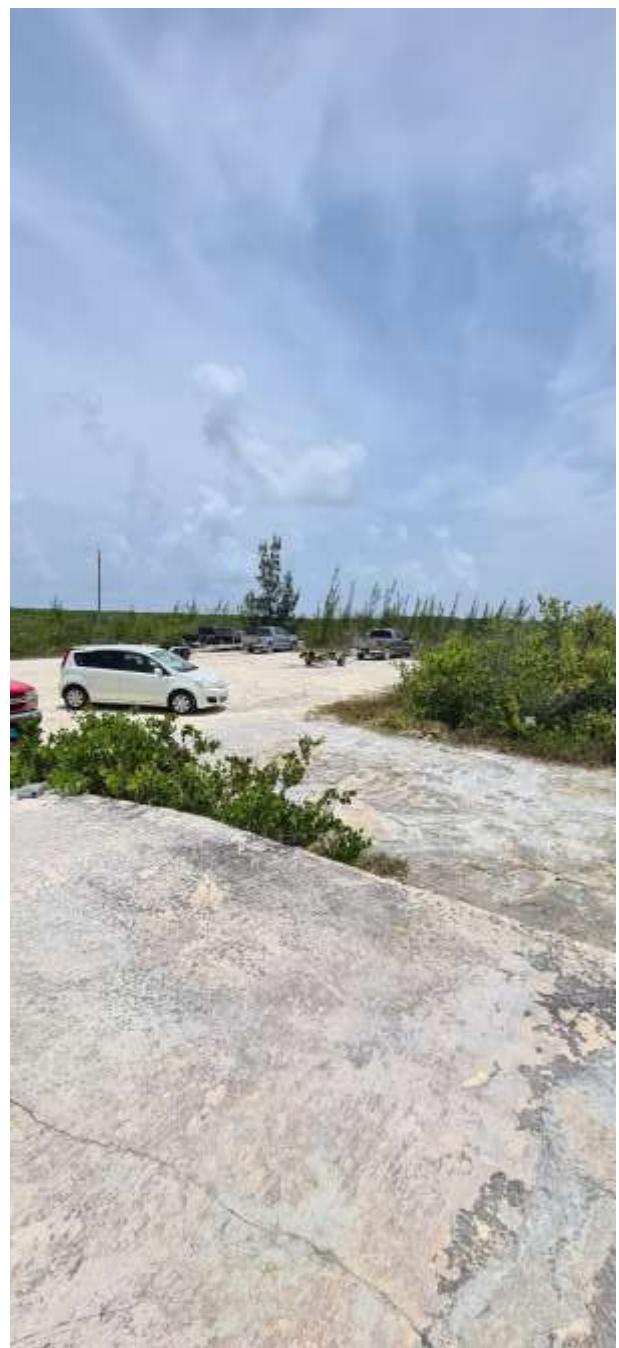
## FIELD PHOTOS OF STRUCTURES

TYPE	EXISTING	DAMAGED	PROPOSED	OUTLINE COST U\$
Breakwater	No			0.00
Quay wall	No			0.00
Jetty on piles	Yes	No		0.00
Slipway	Yes	No		0.00
Gear Stores	No			0.00
Net repair shed	No			0.00
Engine repair	No			0.00
Fish sales Hall	No			0.00
Admin building	No			0.00
Cool Store	No			0.00
Ice maker	No			0.00
Water Tanks	No			0.00
Fuel Tanks	No			0.00
Septic Tanks	No			0.00
Equipment	No			0.00

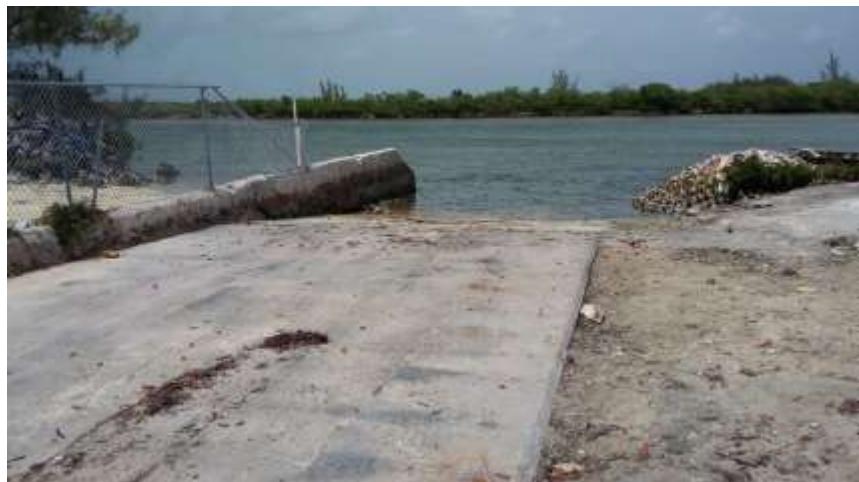
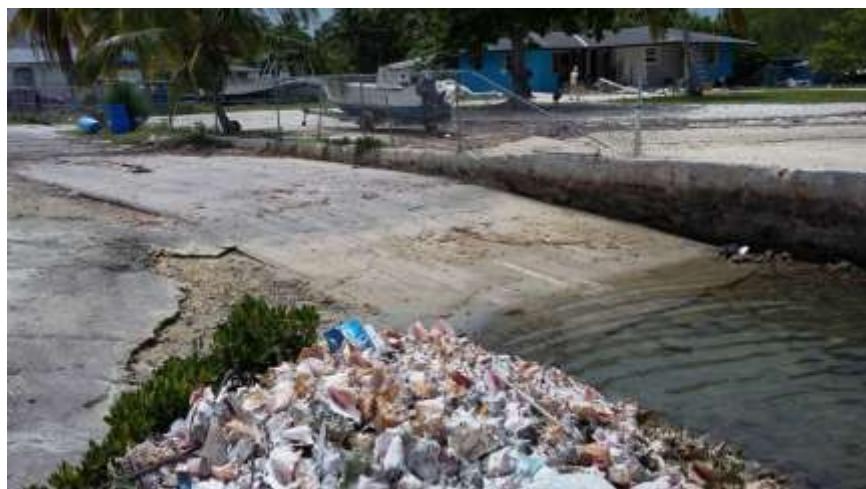
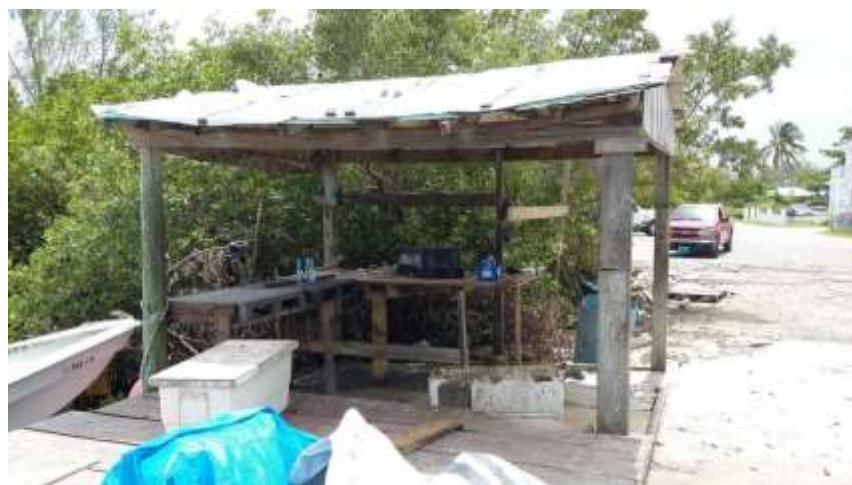
## FIELD PHOTOS OF STRUCTURES

TYPE	EXISTING	DAMAGED	PROPOSED	OUTLINE COST U\$
Breakwater	No			0.00
Quay wall	No			0.00
Jetty on piles	No			0.00
Slipway	Yes	No		0.00
Gear Stores	No			0.00
Net repair shed	No			0.00
Engine repair	No			0.00
Fish sales Hall	No			0.00
Admin building	No			0.00
Cool Store	No			0.00
Ice maker	No			0.00
Water Tanks	No			0.00
Fuel Tanks	No			0.00
Septic Tanks	No			0.00
Equipment	No			0.00
