Water management for better livelihoods

Northwestern Tanzania

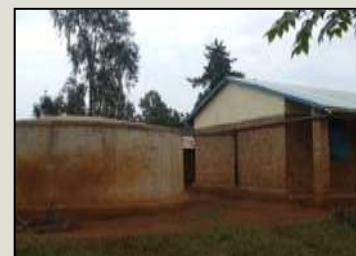
SCHOOL TANKS: Concern Tanzania, Gorta, the Development and Life Relief Association (DELIRA) and Tanzania Water and Environmental Sanitation (TWESA) worked with schools and communities to set up large rainwater harvesting tanks (see photos showing formwork: 50,000 L tanks fed from rainfall on school roofs, to ensure storage of rainwater meets demand for use during the dry season), latrine blocks and small 1,500 L rainwater harvesting tanks which are fed from the latrine roofs, for hand washing. Child to child education methods for good basic hygiene practices are promoted.

Tanks are preferably cylinder in shape; this avoids cracking in the joints, and is cheaper to construct. Tanks are ferro-cement generally built on the ground so that they are easier and cheaper to build and maintain. Foundations are made of stone to ensure durability. They are built by skilled artisans who are locally available. Plastic tanks of the same capacity can be used but they are less durable and more expensive. The inside of the tank is plastered with a mix of sand, cement and water proof cement that improves the quality of the tank (water proof cement acts as a water seal to prevent leakage). A cover is made from wire mesh, cement and sand, with a manhole to enable entry for cleaning. The cleaning can be done at six monthly intervals or at the start of every rainy season by using brooms followed by chlorine disinfection to kill pathogens. The downpipes are connected to the tank so water flows inside, and an outlet pipe and tap is connected at the lower end of the tank to release water. The pipe comes from the reinforced concrete bed and extends only 30cm. A wash out pipe extending from the tank allows it to be cleaned.

- tanks are built on the ground with stone foundations and are cylinder in shape to avoid cracking. This is **cheaper to construct and easier to maintain** - plastic tanks are less durable and more expensive. The inside is plastered with a mix of sand and water proof cement to prevent leakages;

- the top of the tanks are made from wire mesh, cement and sand, with a manhole for entry for cleaning, done at 6 month intervals using normal brooms, followed by chlorine **disinfection**. As well as the tap, a wash out pipe extends from the tank to allow **cleaning**;
