STATUS OF COASTAL EROSION OF VIETNAM AND PROPOSED MEASURES FOR PROTECTION

Assoc. Prof., Dr. Ngo Ngoc Cat

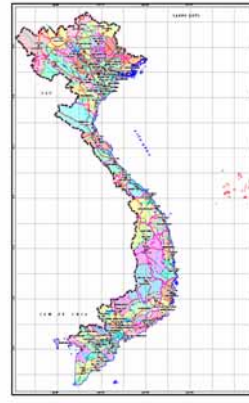
The coastal zone of Vietnam:

The coastal zone of Vietnam is 3,260 km long, extending through the territories of 24 provinces and cities, which include 127 urban and rural districts, 21 towns and 6 cities (Ha Long, Vinh, Hue, Quy Nhon, Nha Trang, Vung Tau). Here occur a series of interactive processes between the land and the sea, between the dynamic forces of rivers and the sea, between the natural and human processes, etc. Along the coast of Vietnam in average in every 20 km there is a river mouth. The landforms of the coastal zone of Vietnam are multiform and diverse. In many areas the landforms are strongly dissected, giving the coast many beauty spots. The coastal zone of Vietnam also receives many natural calamities, causing multidirectional impacts on the nature and socio-economic conditions. In particular the coastal erosion is causing many difficulties for the life of the coastal population.
