STATUS OF COASTAL EROSION OF VIETNAM AND PROPOSED MEASURES FOR PROTECTION

Assoc. Prof., Dr. Ngo Ngoc Cat
Assoc. Prof., Dr. Pham Huy Tien
Prof., DSc. Do Dinh Sam
Eng. Nguyen Ngoc Binh

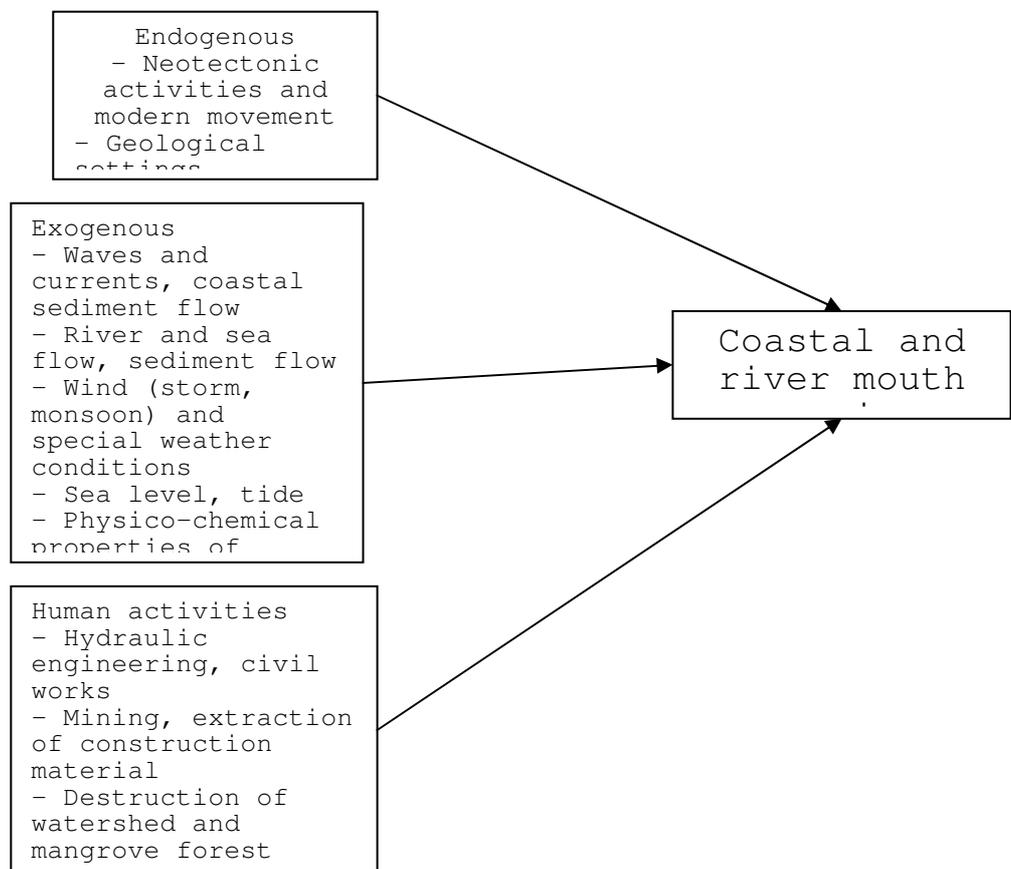
Fig 1: Factors causing coastal and river mouth erosion and sedimentation (Pham Huy Tien et al., 2005)

In a particular coastal section with known geological settings and lithological composition of the coast, erosion or sedimentation is due to one of three groups of causes: exogenous, endogenous and human, or a combination of 2 or 3 of those groups. For the coastal and river mouth areas of our country, the erosion and sedimentation are mainly caused by exogenous factors, which are mainly wave and tide. Besides, the lithological composition of the coastal formations is very important. For each coastal section there are different causes and mechanism of sedimentation and erosion.
